U.S. GEOLOGICAL SURVEY

Friday, December 12, 2014

Bob McLaurin
Town of Jackson
PO Box 1687
150 East Pearl Avenue
Jackson, WY 83001

At the invitation of the Wyoming State Geologist, Tom Drean, we, Rex Baum and Jonathan Godt, visited the site of the Budge Drive landslide on November 18, 2014. The purpose of the visit was to observe the landslide and review geological and geotechnical data collected so far by the Town of Jackson and its consultants and to identify any significant hazards not yet recognized or addressed by ongoing investigations. Mr. Wallace Ulrich and Mr. Jason Rolfe led us on a tour of the site during the morning of Nov. 18. Mr. Ulrich provided electronic copies of documents describing results of investigations of the landslide by Landslide Technology¹ and by others; extensometer measurements made by Dr. Roger Bilham (Univ. of Colorado, Boulder); images of ground-based InSAR data collected by IDS Corporation; and displacement surveys, maps, and photographic images of the site. After making field observations we returned to our hotel for the afternoon to review the electronic data and reports in light of our observations. At the end of the day, we shared our observa

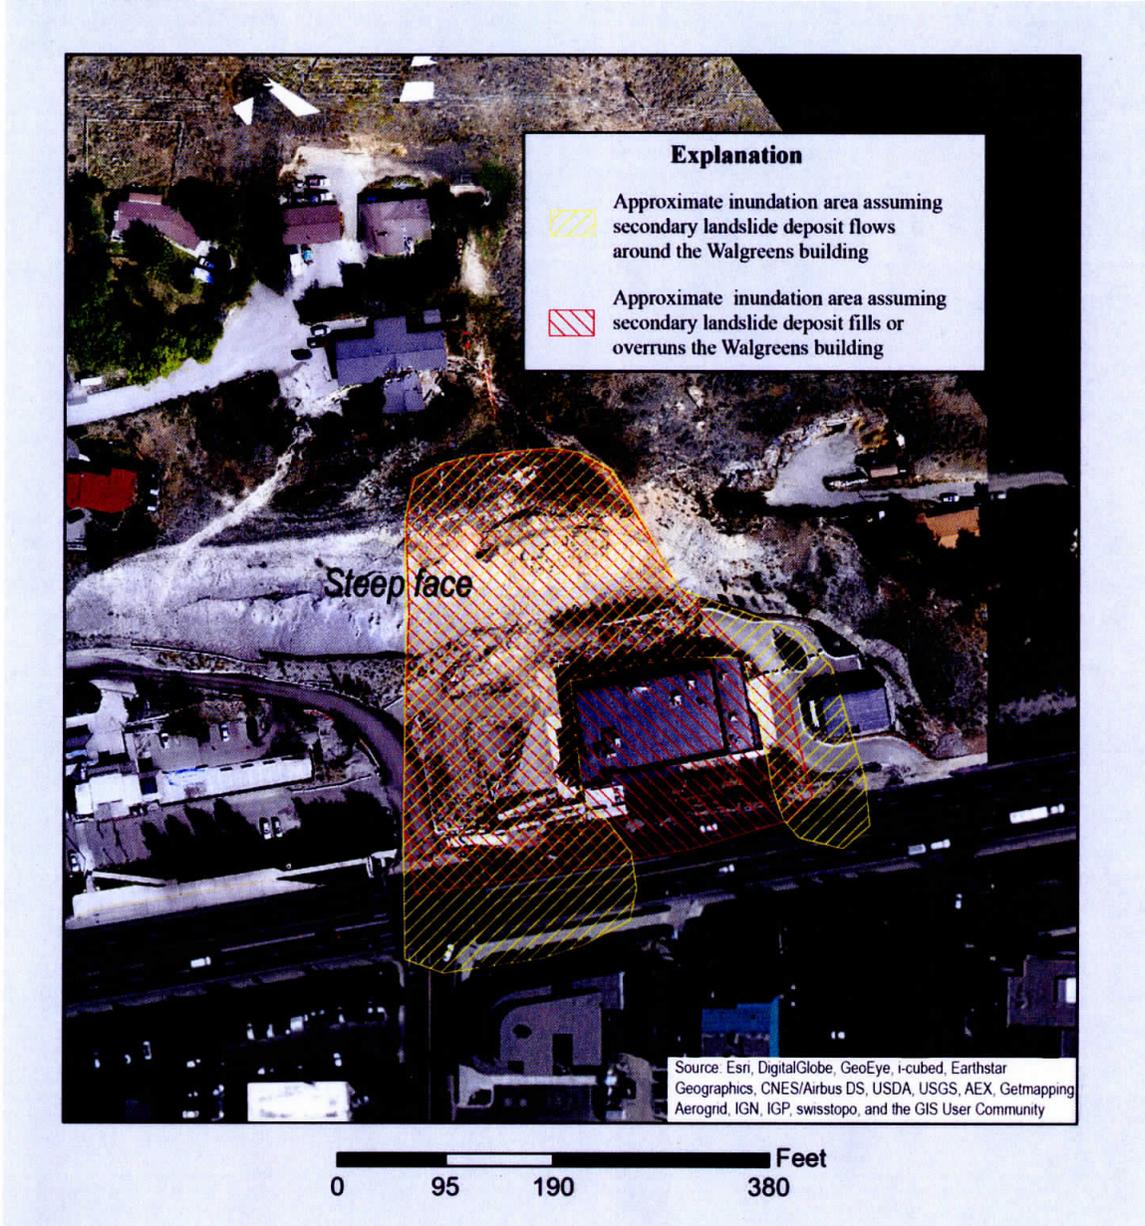
3. Based on observations of other landslides and the potential volume (13,000 yd³) a secondary landslide calving off the steep face of the Budge Drive landslide could move about 300 to 400 ft, or perhaps farther. Volume is a primary factor in determining travel distance (Legros, 2002). Our travel-distance estimates are based on area-volume relationships for debris flows and rock avalanches determined by Griswold and Iverson (2007). Two possible inundation areas are depicted in Figure 1: one scenario assumes that the landslide deposit fills or overruns the current Walgreens building (red hachured area) and the other scenario assumes that the moving material flows around the building (yellow hachured area). The section of the small building to the east of the Walgreens within the yellow hachured area coincides approximately with the covered parking area of that building, which is open on the side facing the current Budge Drive landslide and therefore not likely to deflect moving landslide debris.

Figure 1. Map showing approximate extent of deposits from potential secondary landslide. (Orthophoto image of active landslide area courtesy of Jason Rolfe, of Tributary Environmental, Jackson, Wyoming)
