Name/Description: Westview Townhomes

Physical Address: 125 West Highway 22

**-ENVIRONMENTAL ANALYSIS-  
WESTVIEW TOWN HOMES PROJECT,  
JACKSON, WYOMING**

**GEOTECHNICAL INVESTIGATION REPORT  
WEST VIEW TOWNHOMES  
1255 W HIGHWAY 22  
JACKSON, WYOMING**

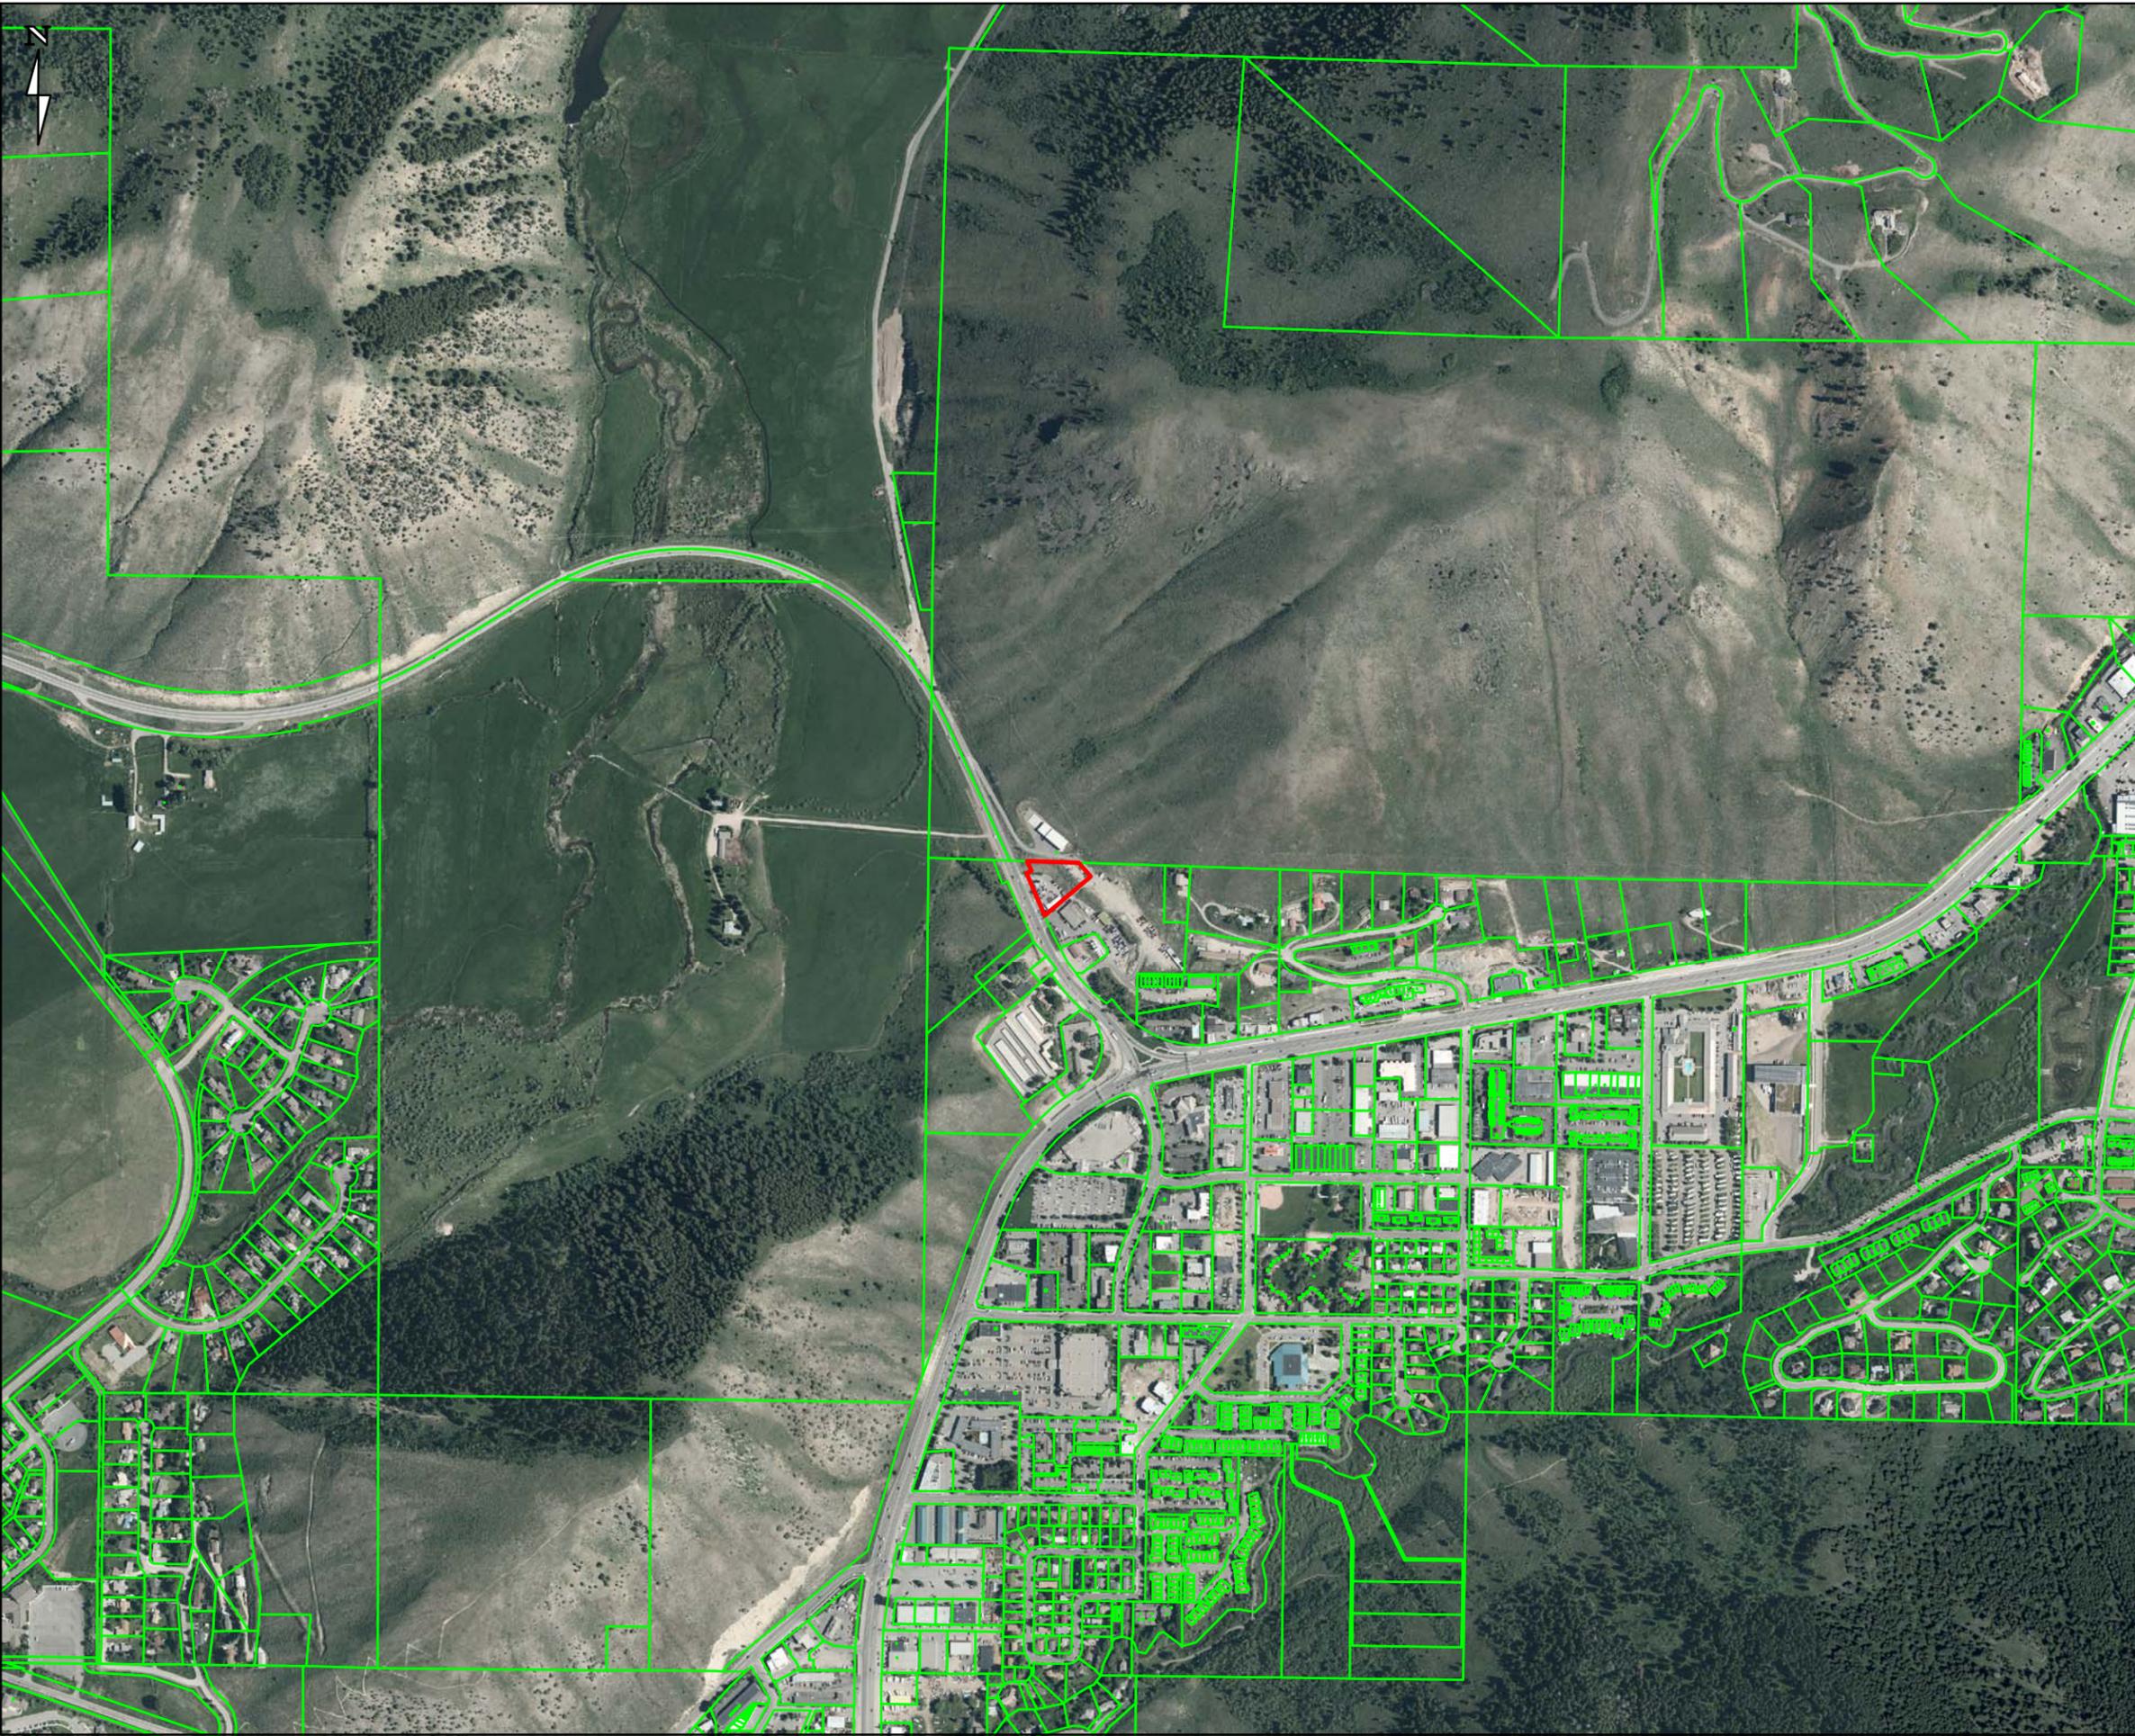
Attachment 1  
Aerial photograph depicting the location and  
site characteristics of the Westview Town Homes  
property in Jackson, Teton County, Wyoming.

- 1)** Aerial photograph depicting the location and site characteristics of the Westview Town Homes property in Jackson, Teton County, Wyoming.
- 2)** Aerial photograph depicting vegetative covertypes within the Westview Town Homes property in Jackson, Teton County, Wyoming.
- 3)** Aerial photograph depicting mapped mule deer habitat and historic observations on and in the vicinity of the Westview Town Homes property in Jackson, Teton County, Wyoming.
- 4)** Aerial photograph depicting proposed development within the Westview Town Homes property in Jackson, Teton County, Wyoming.

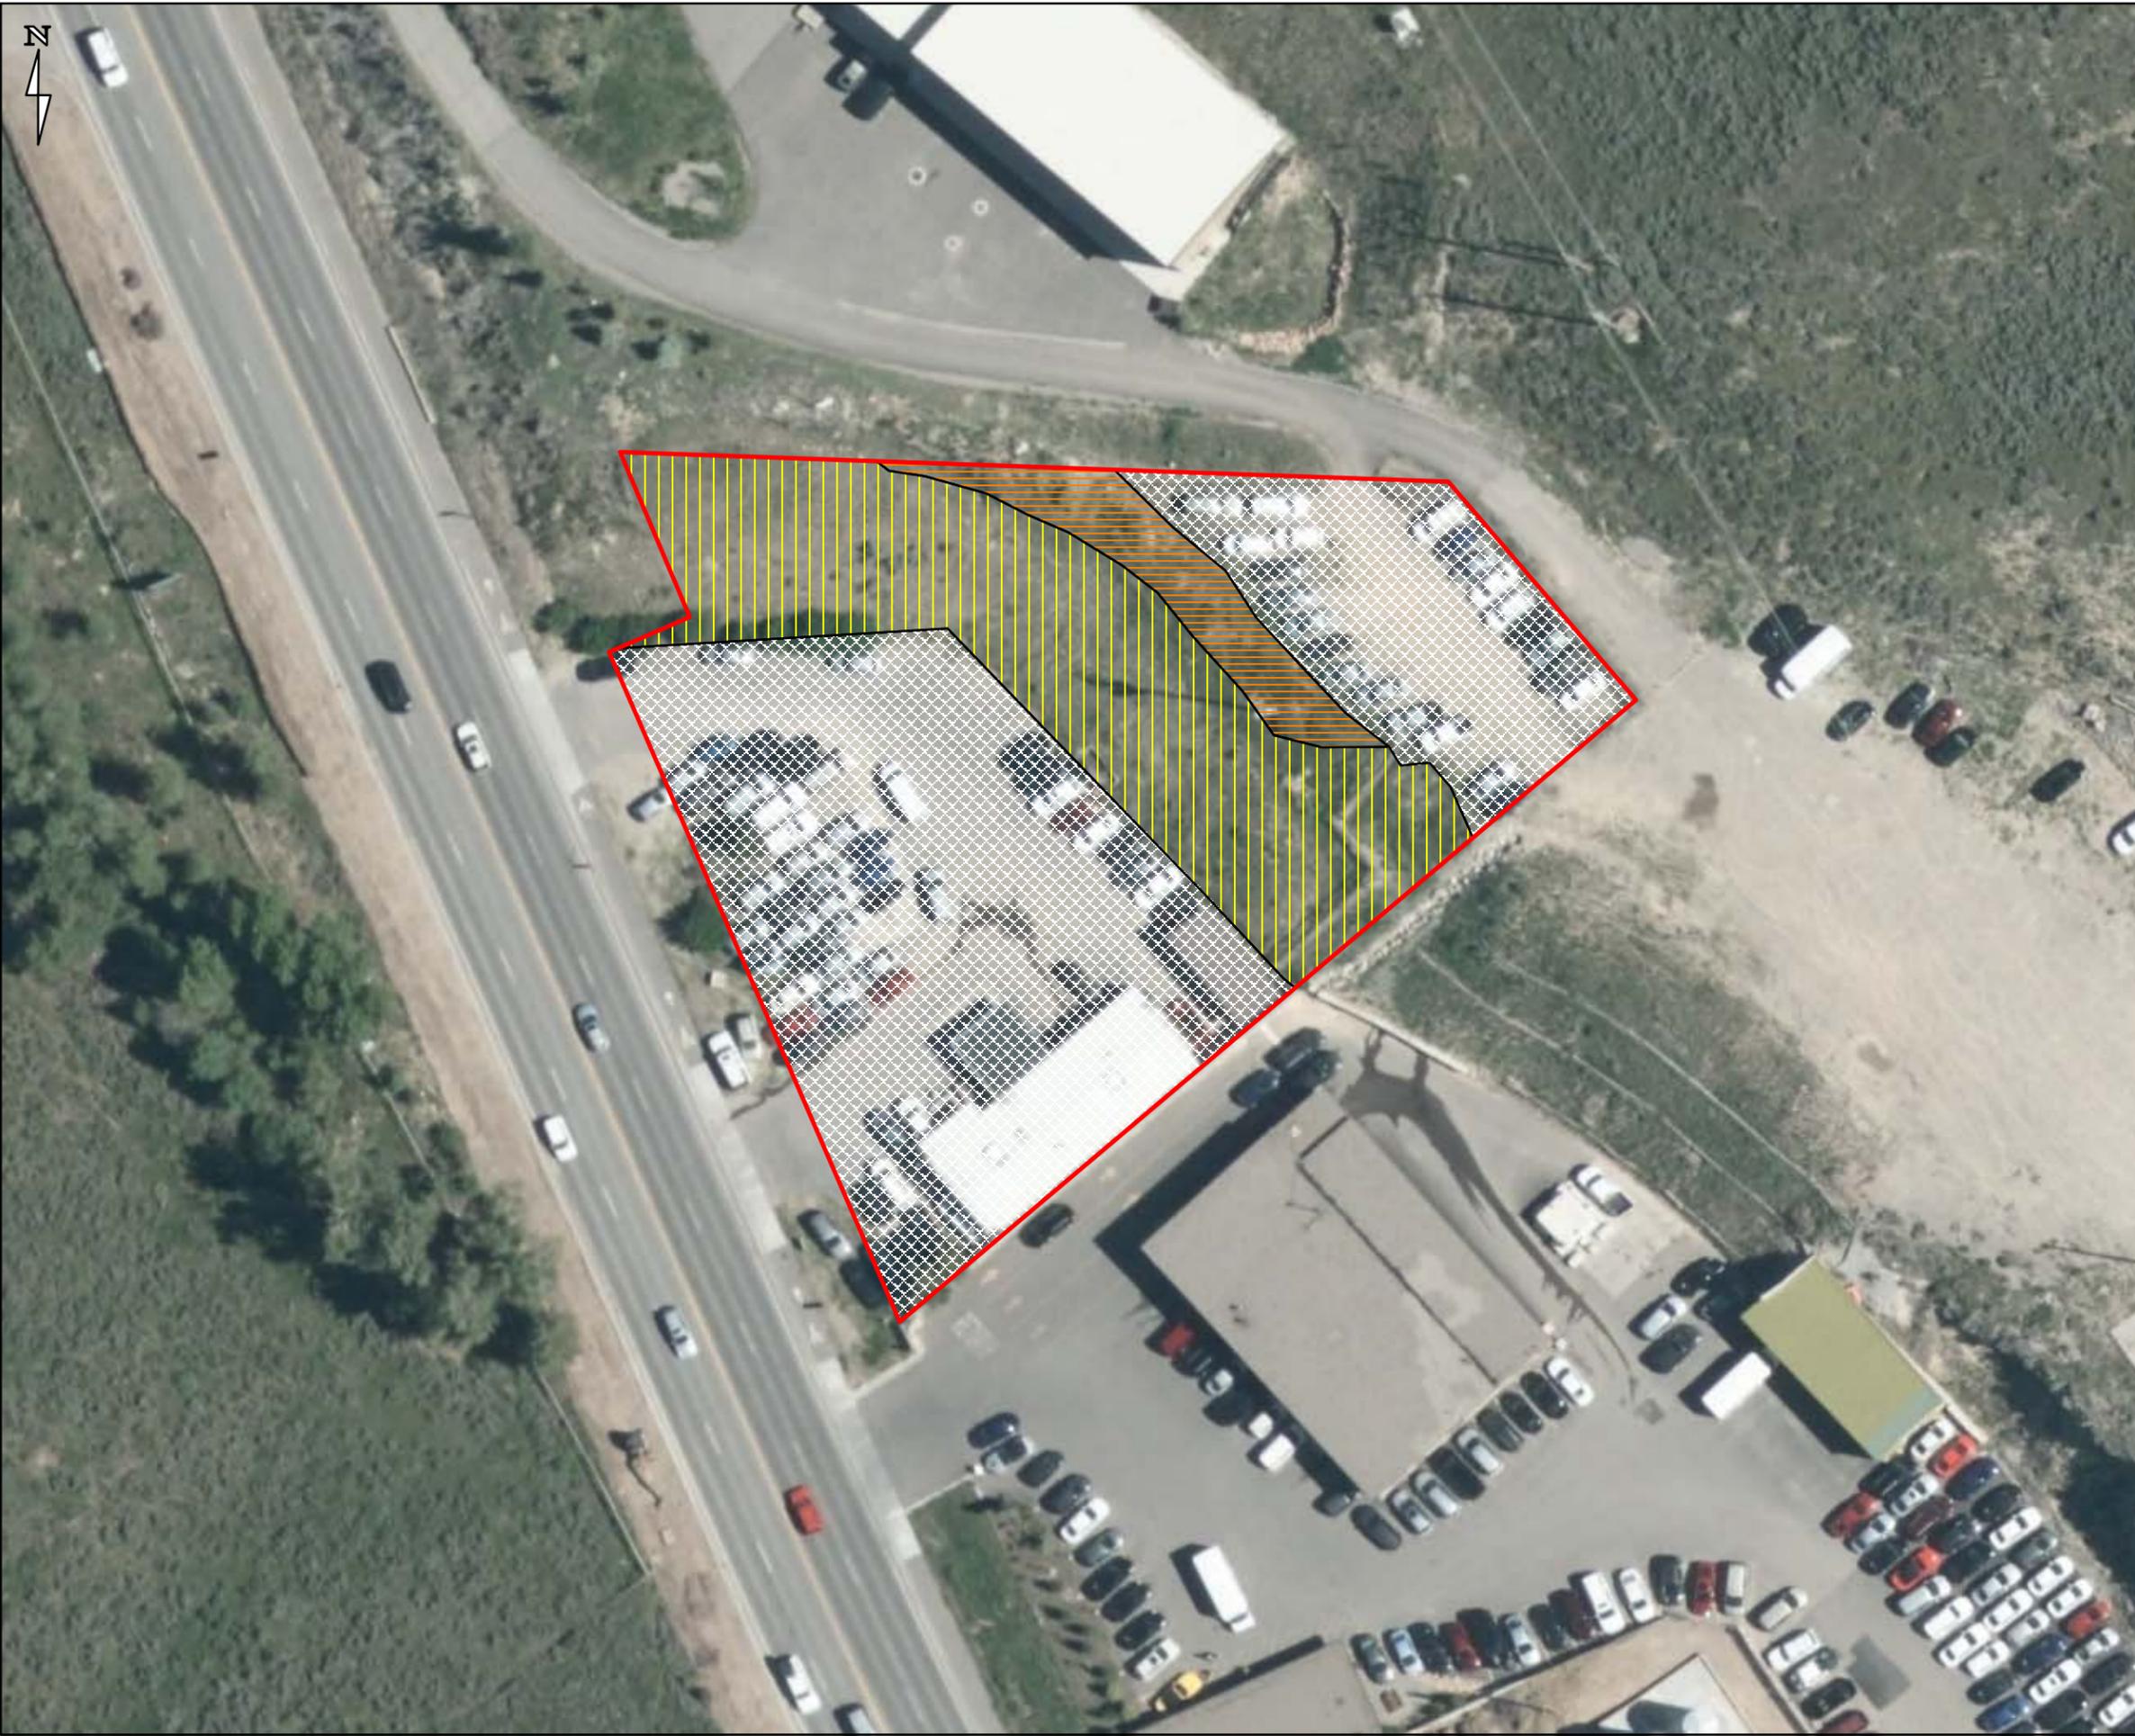
Attachment 2  
Aerial photograph depicting vegetative  
covertypes within the Westview Town Homes  
property in Jackson, Teton County, Wyoming.

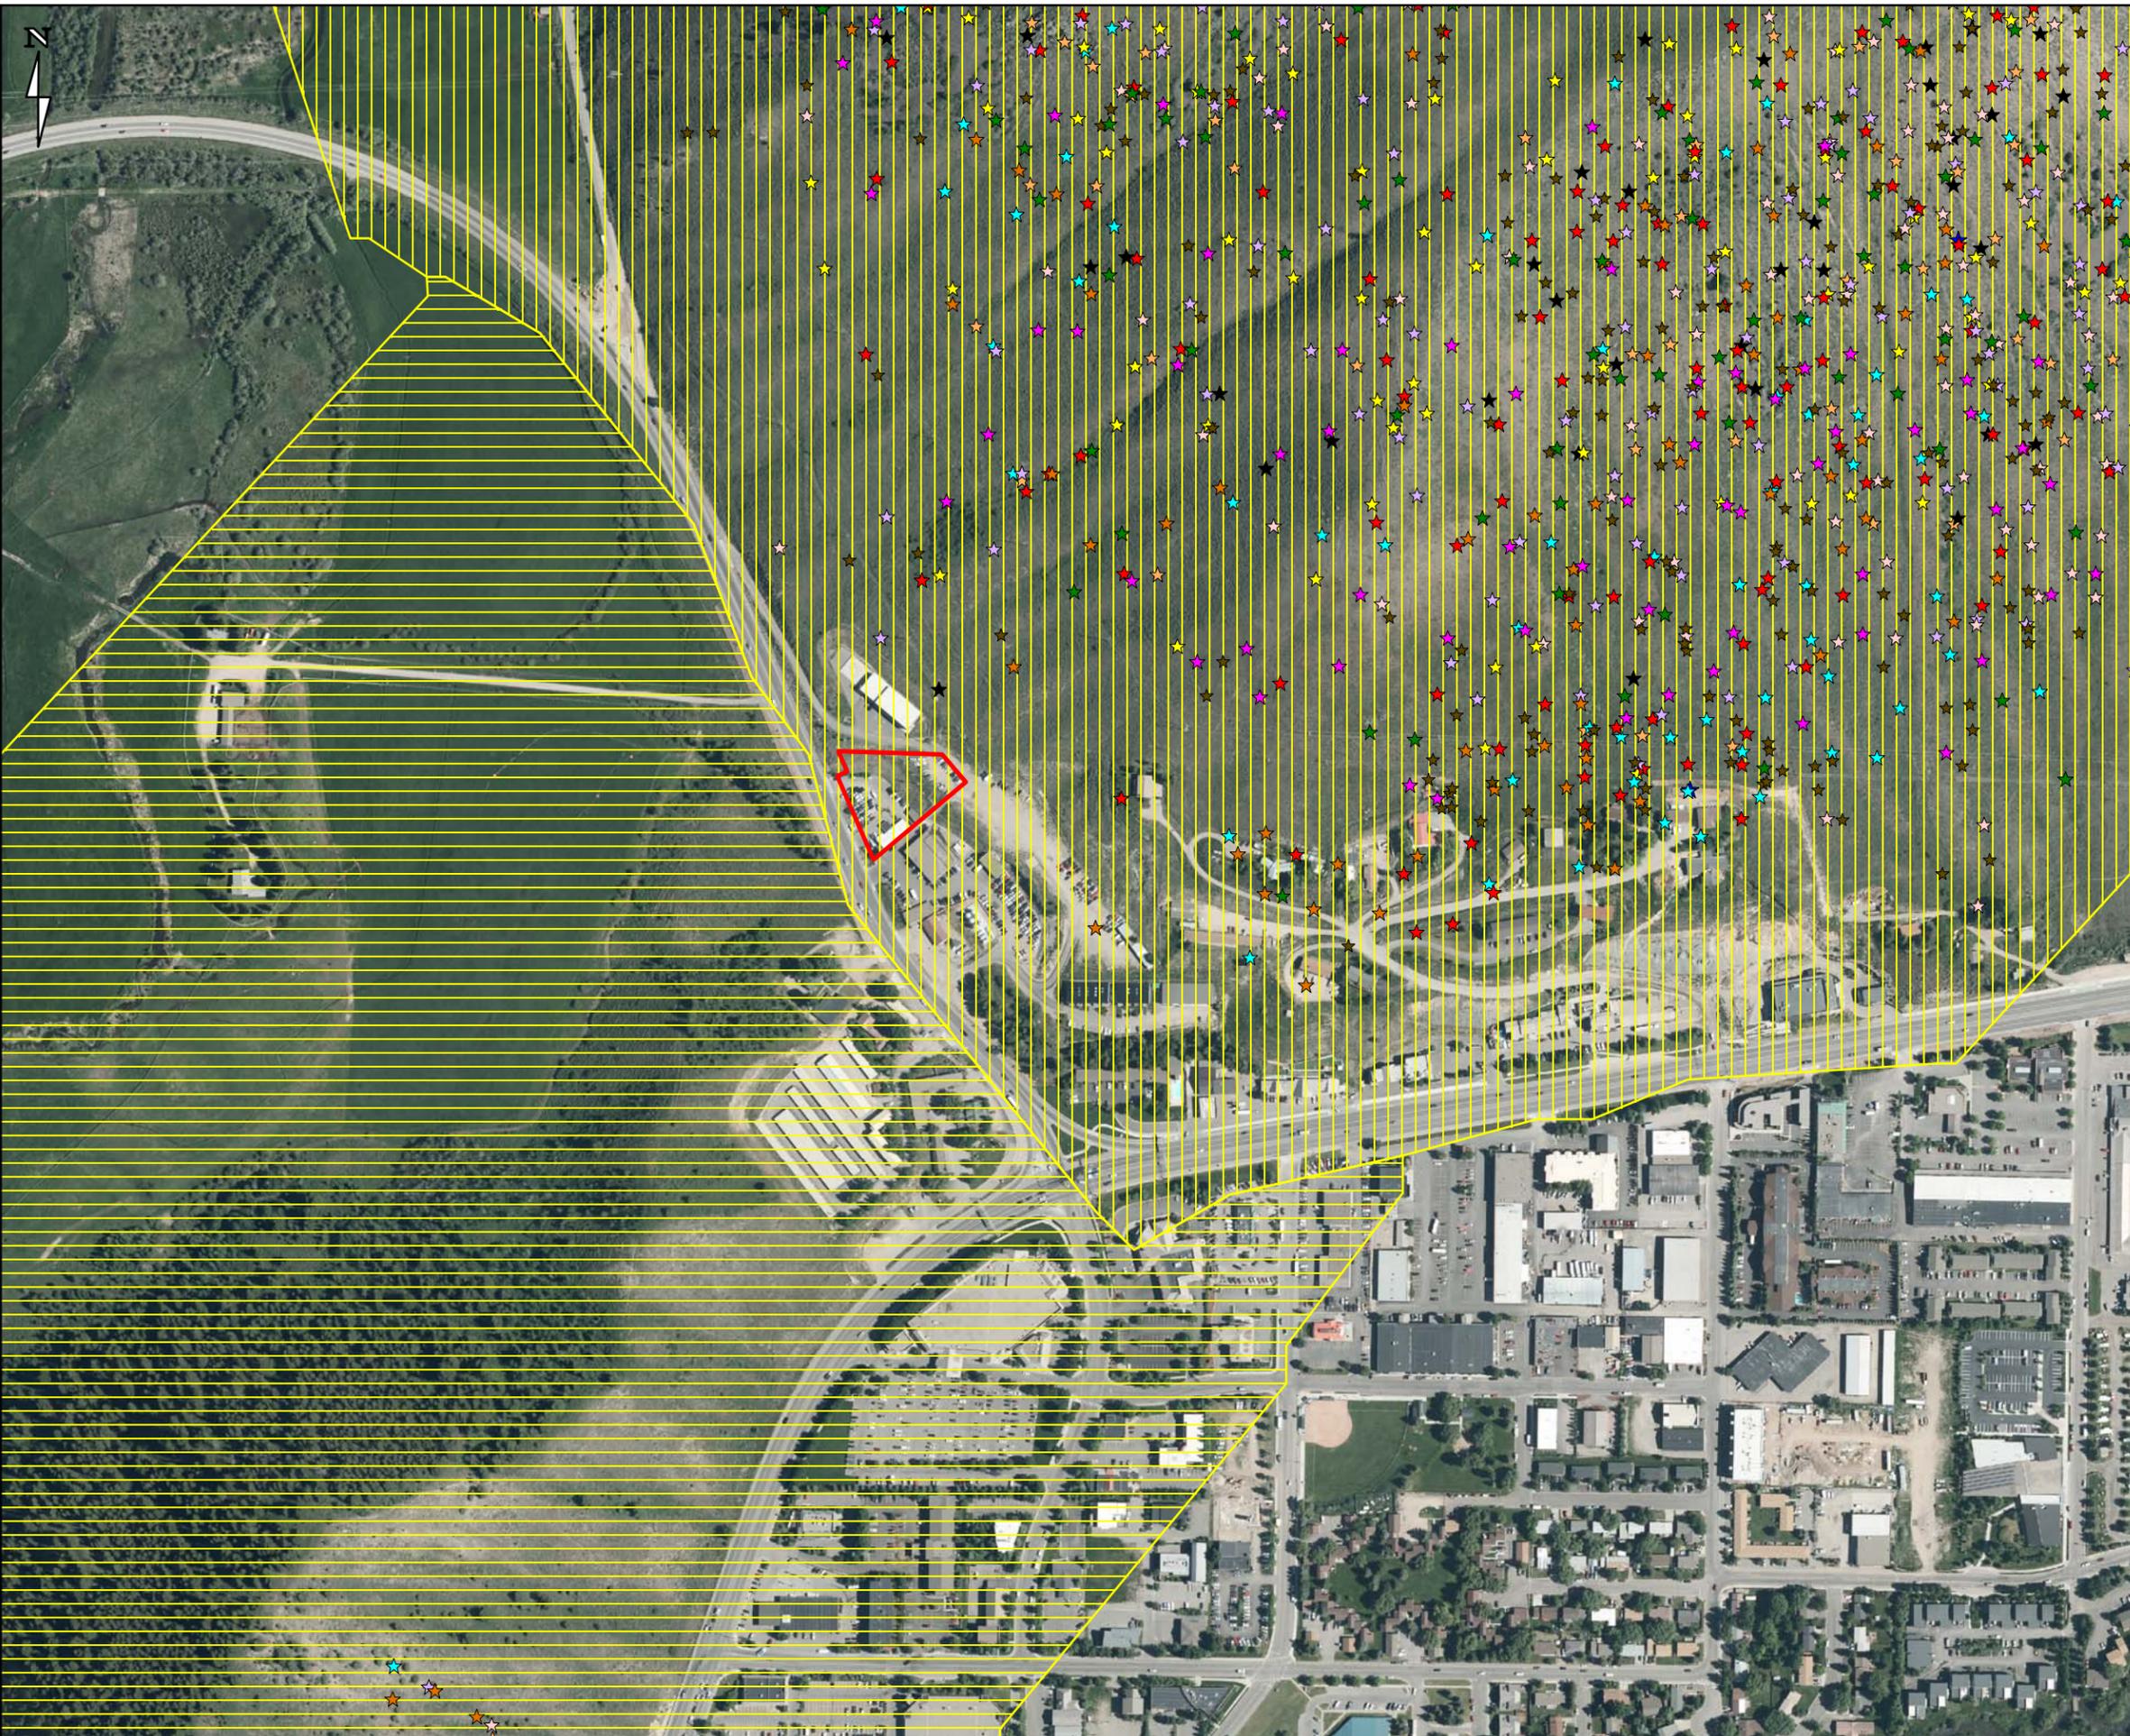
Attachment 3  
 Aerial photograph depicting mapped mule deer  
 habitat and historic observations on and in the  
 vicinity of the Westview Town Homes property  
 in Jackson, Teton County, Wyoming.

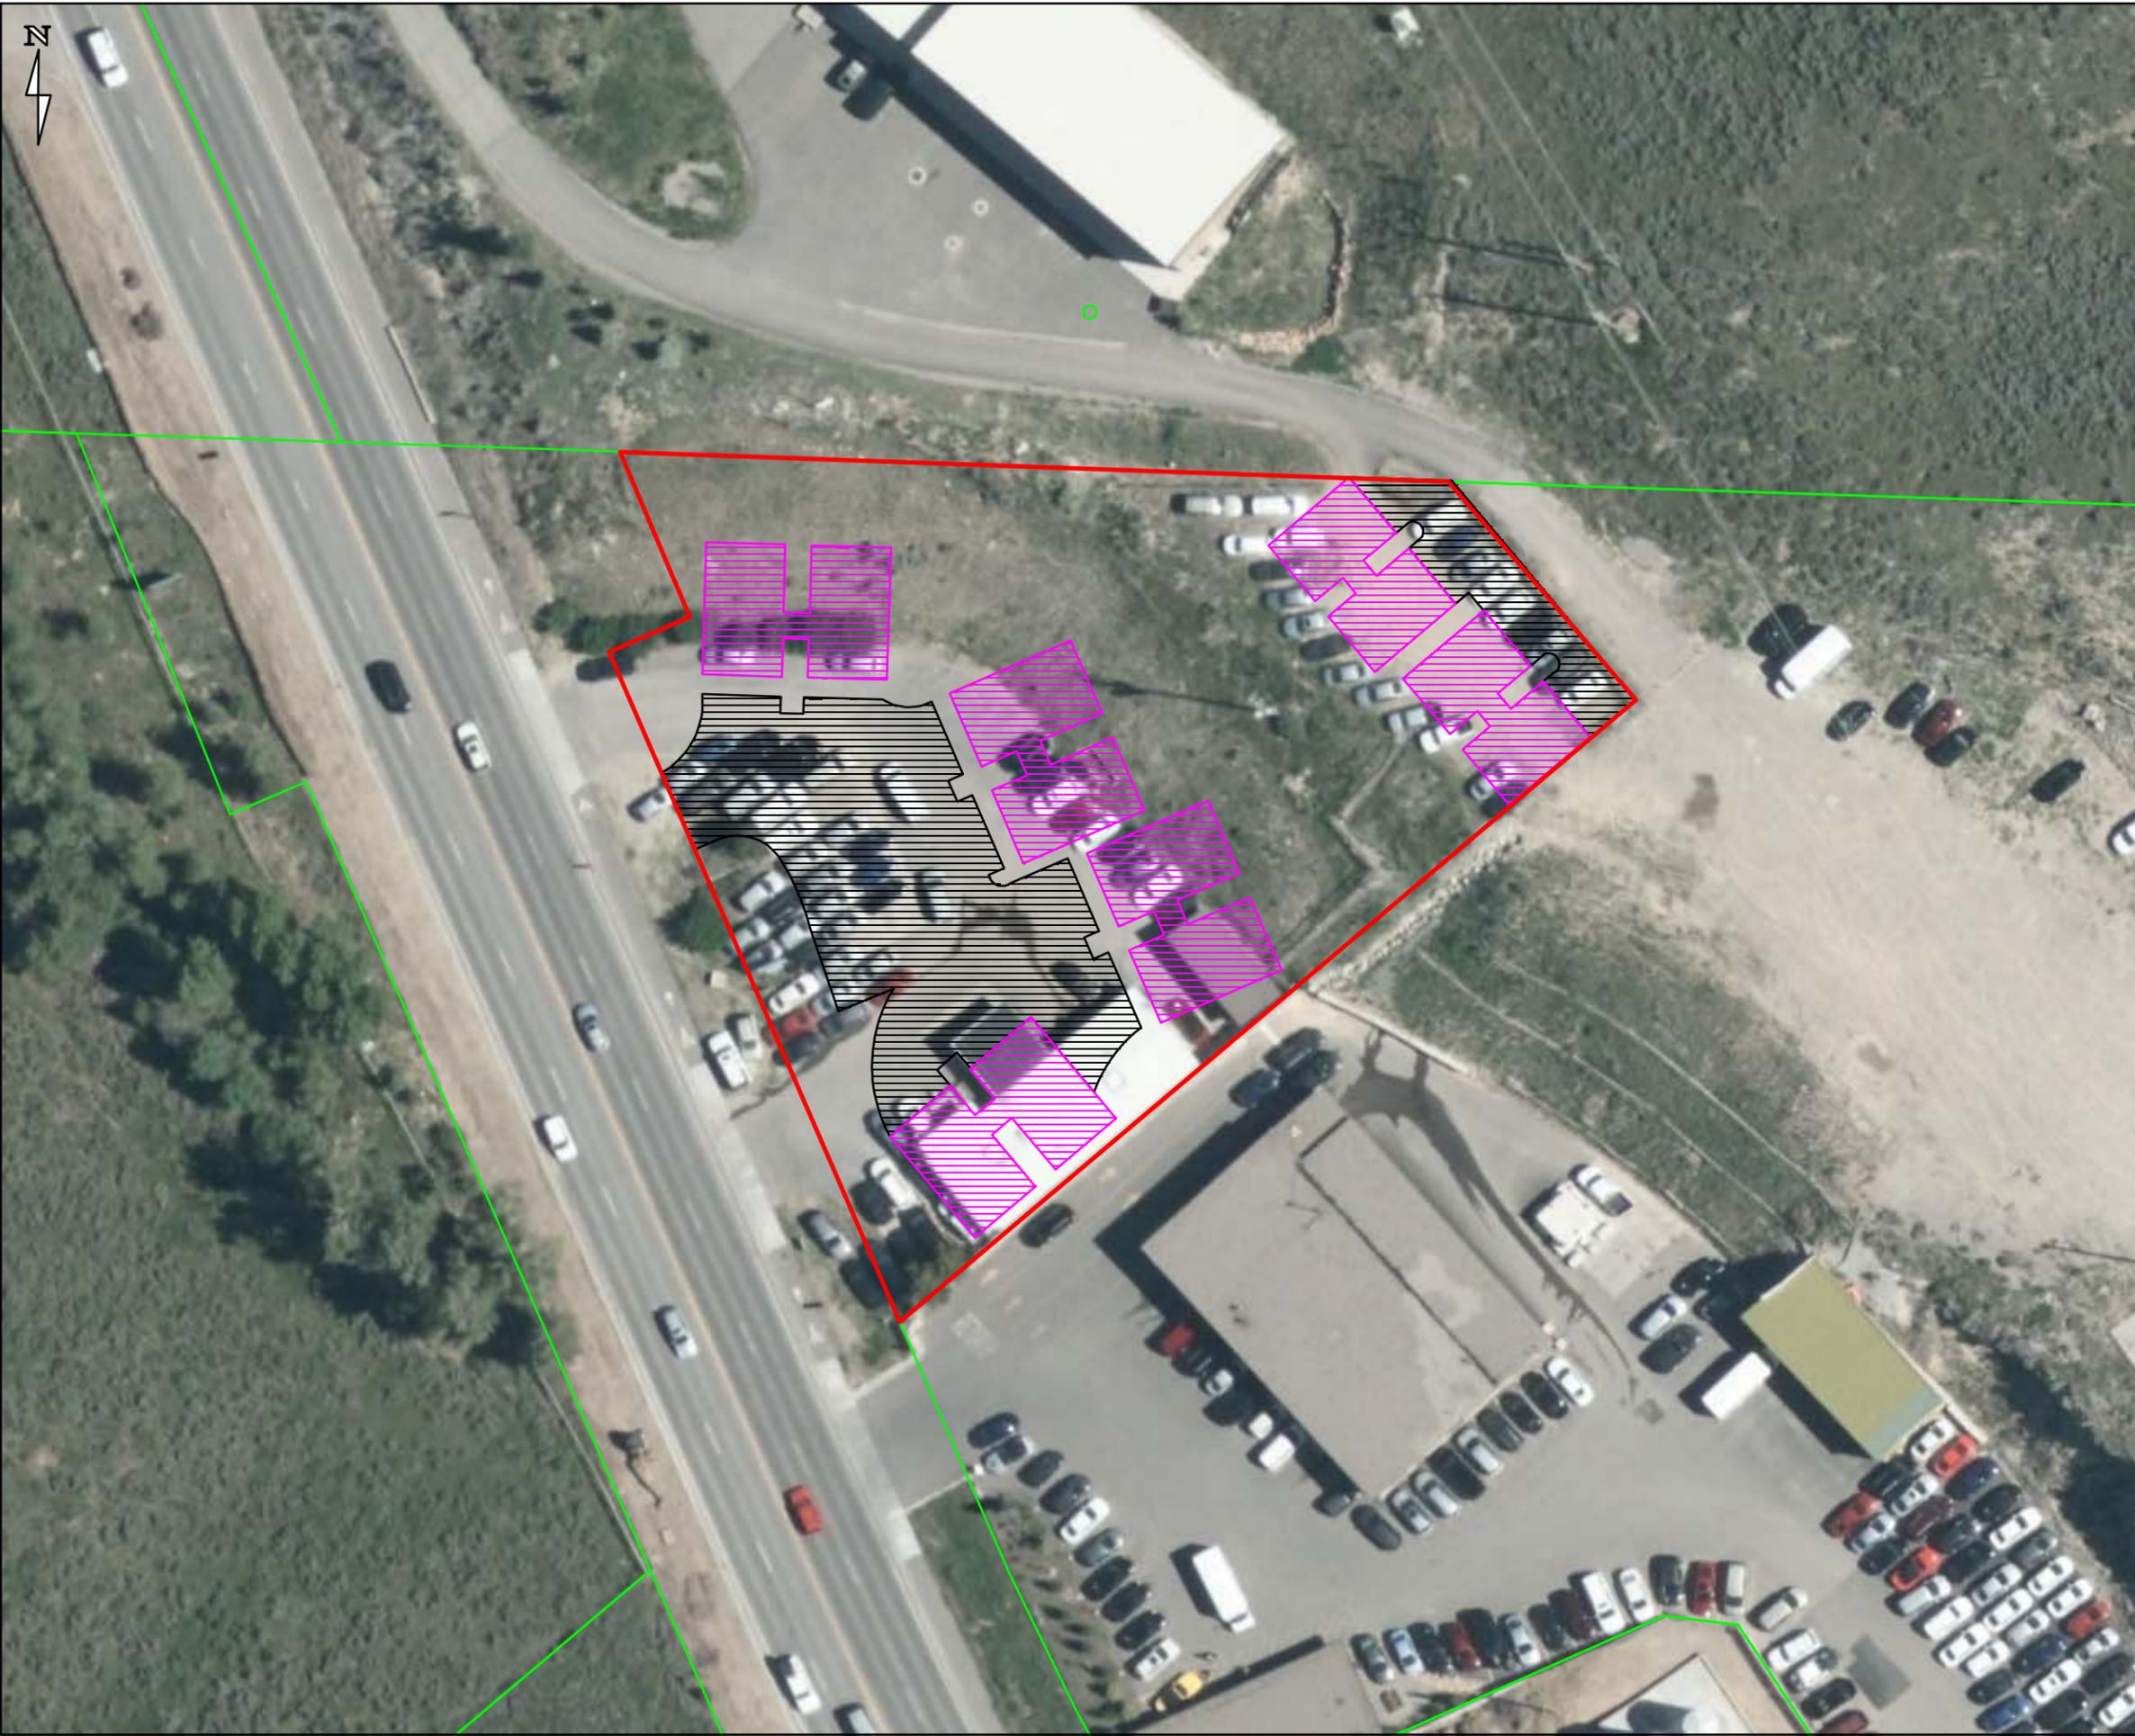
Exhibit 4  
Aerial photograph depicting proposed  
development within the Westview Town Homes  
property in Jackson, Teton County, Wyoming.

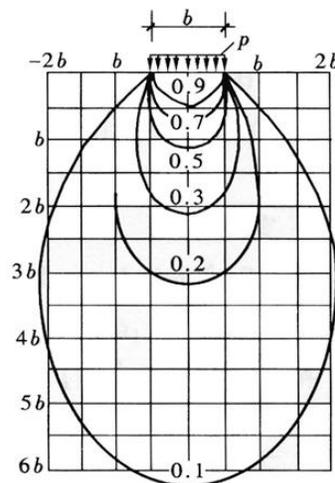
Figure 1: Boussinesq Vertical Stress Distribution below Continuous Footing

Although assuming foundation pressures induced on underlying soil follow a linear distribution of 0.5H:1V, often referred to as the "2:1 Method", it is not the only approach to estimate pressures applied to soil by foundation elements. Boussinesq stress distributions, based on elasticity theory, have more of a "bulb" shape. The figure below shows the pressure distributions for a strip footing of width =  $b$ . As is shown in the figure, a pressure equipotential line equivalent to 30% of the foundation pressure ( $0.3p$ ) extends to an approximate depth of  $2b$ , commonly referred to as the foundation's "zone of influence", and only extends laterally to approximately  $0.75b$  from the center of the footing. Therefore, in our opinion, requiring the excavation to extend the lateral distances suggested by LT is not necessary.

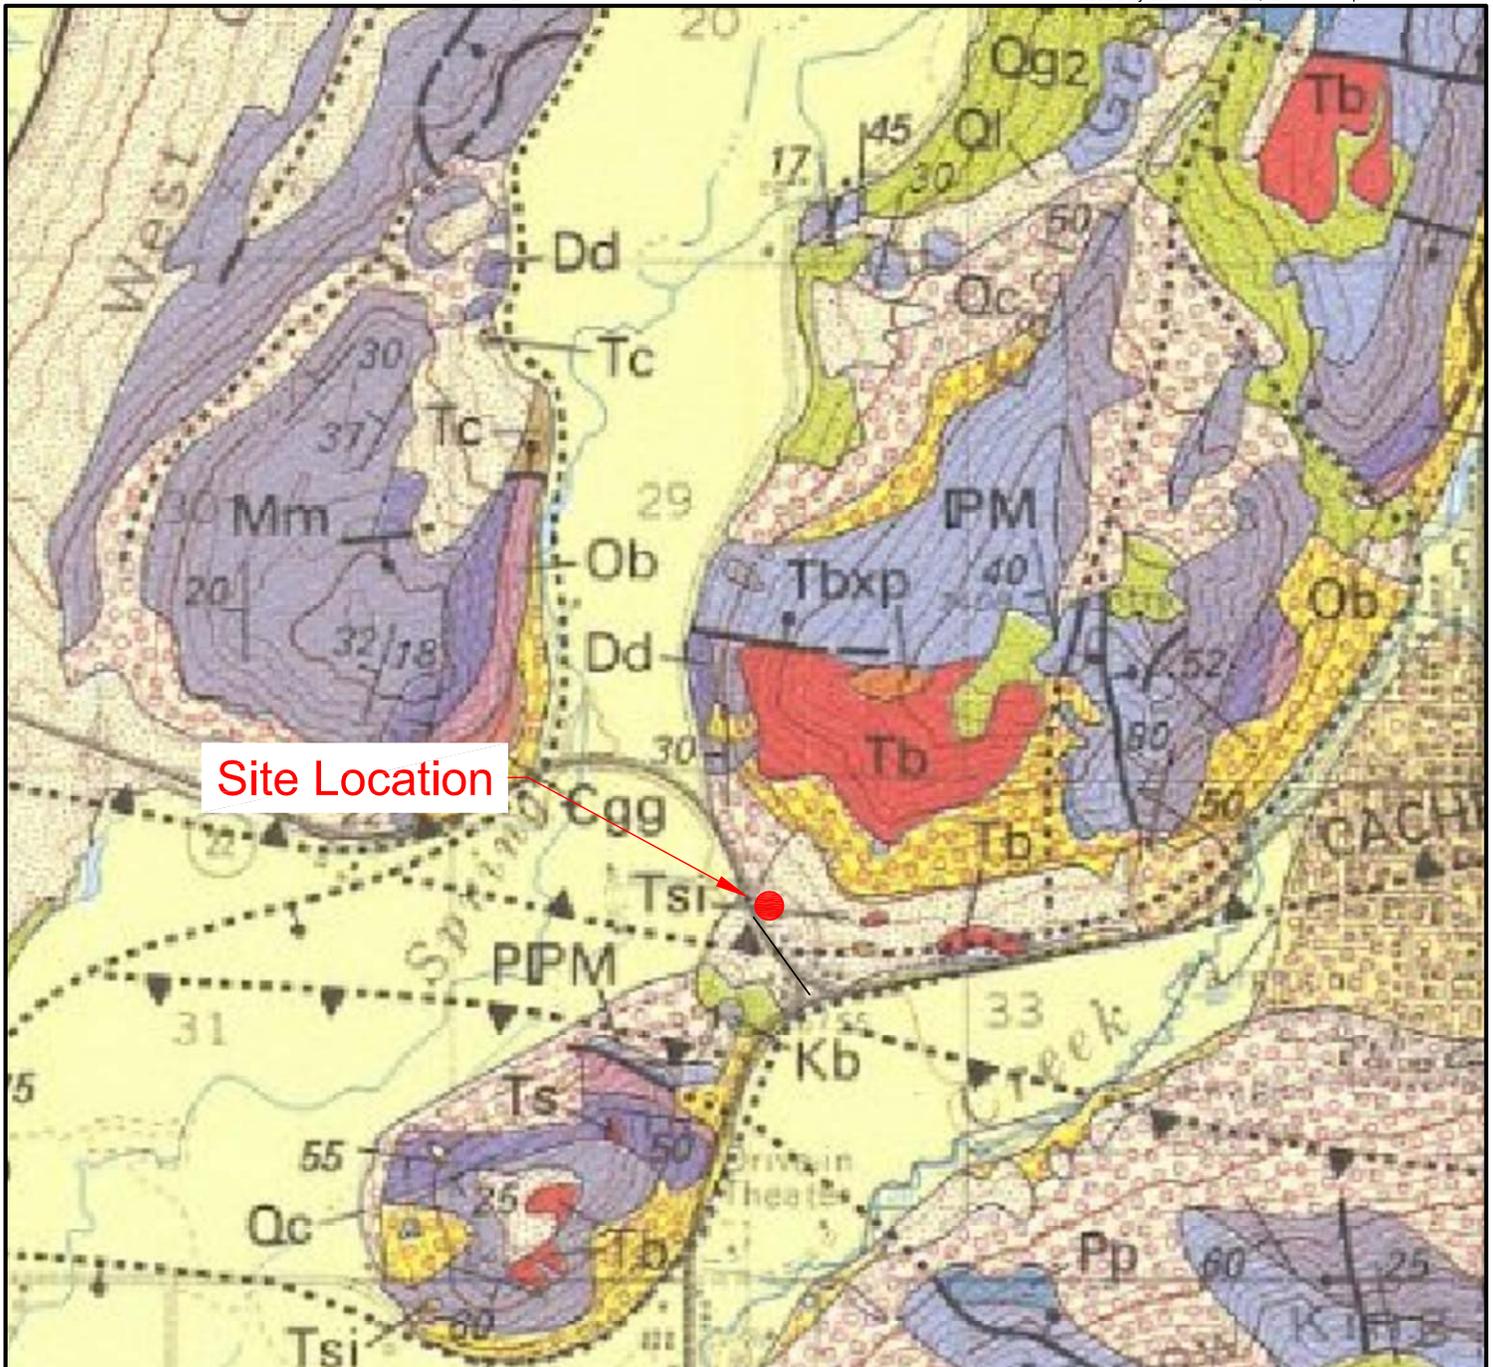
Map adapted from:  
 "Love et al, 1992, Geologic Map of the Grand Teton National Park, Teton County, Wyoming, Map I-2031"

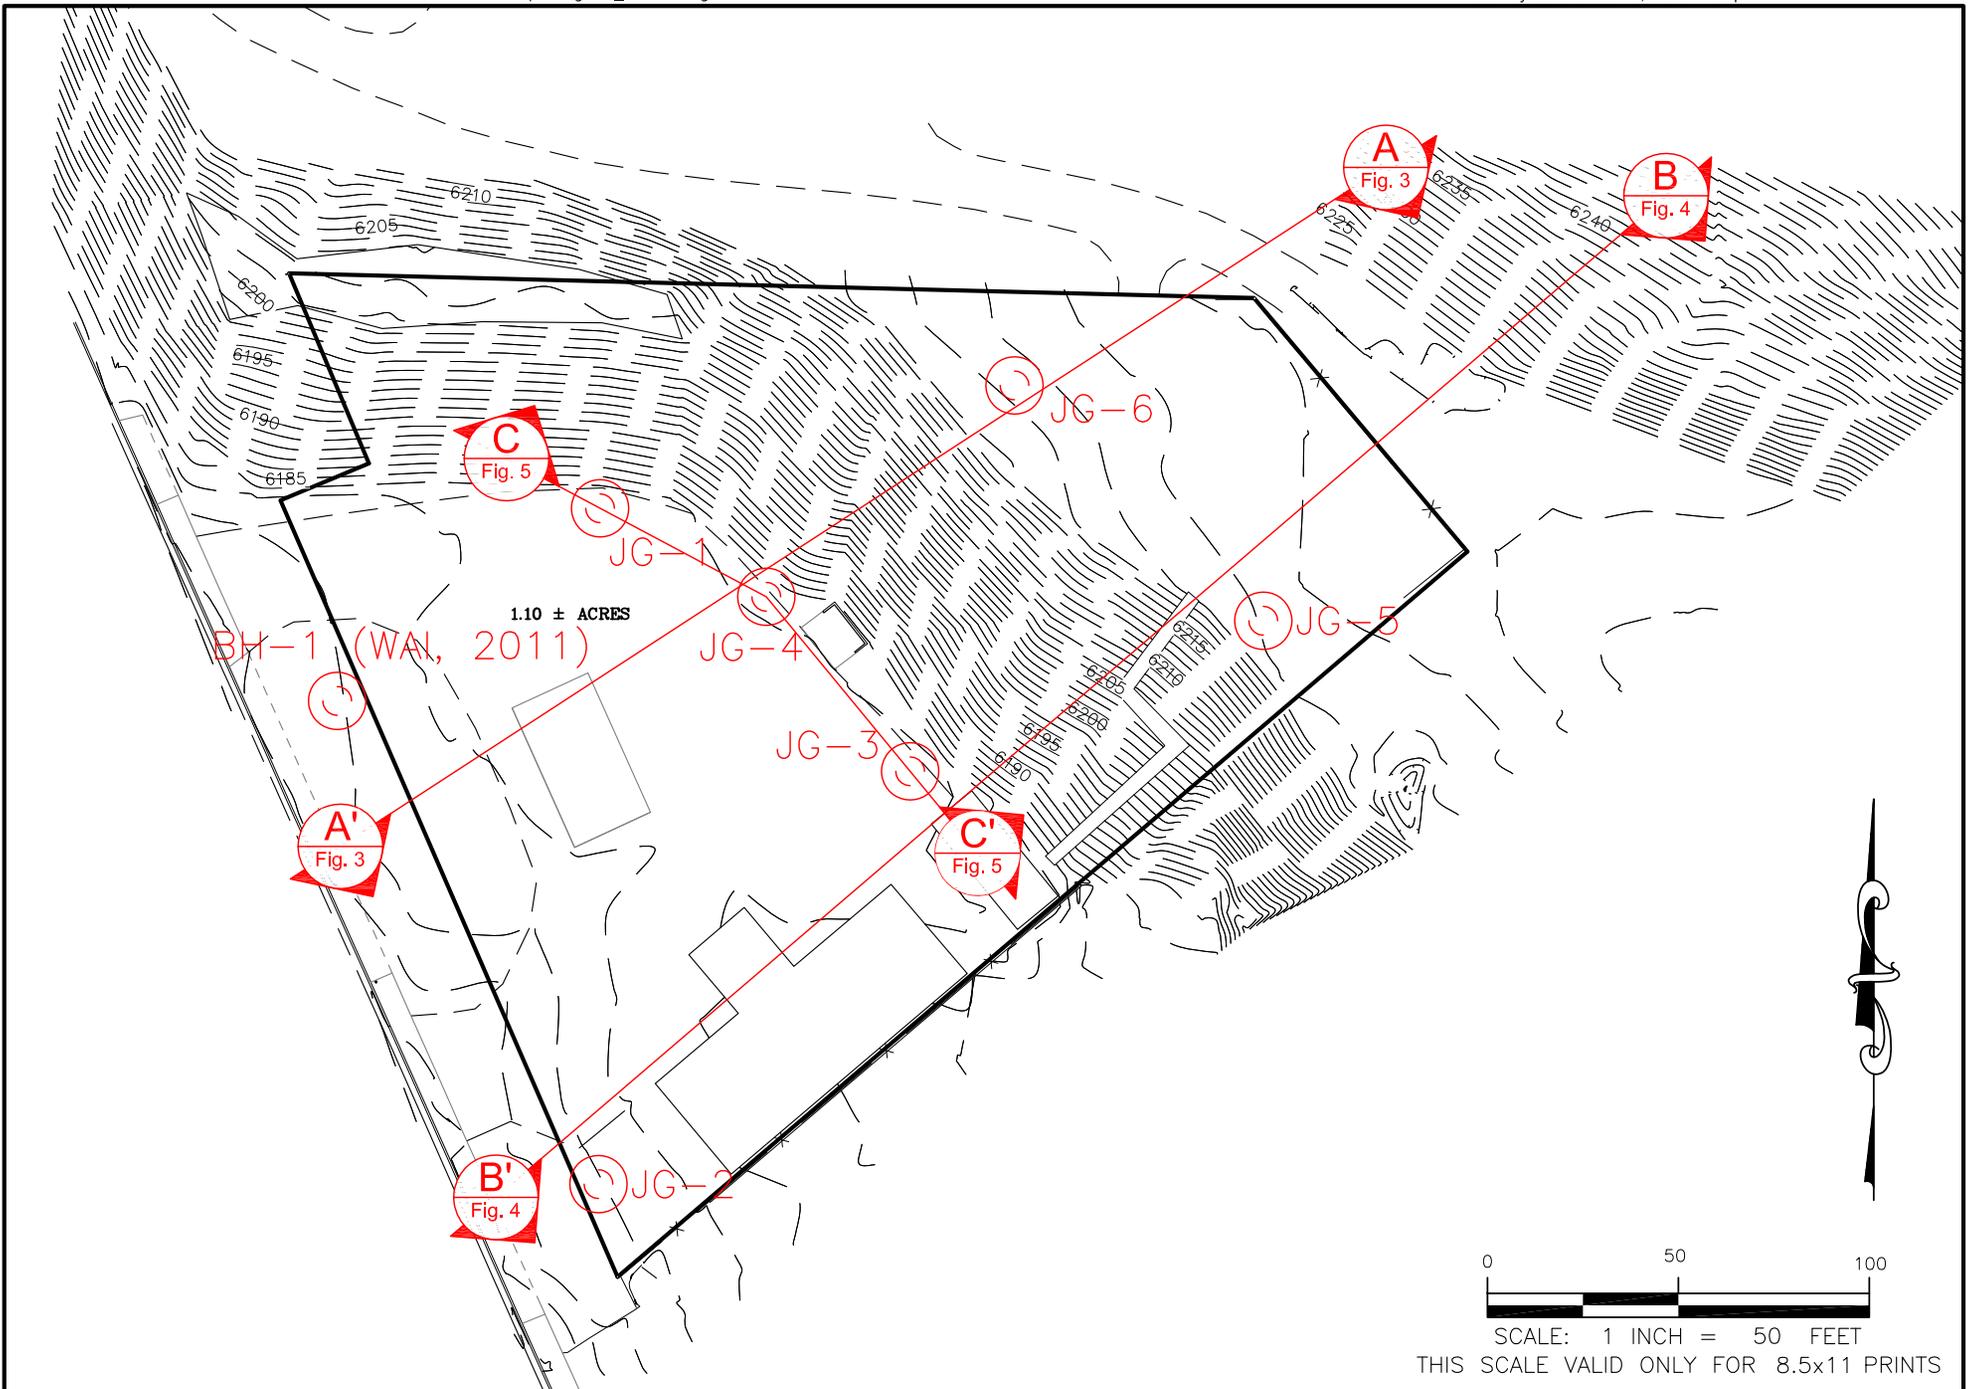
SHEET TITLE:  
**FIGURE 2**  
**BOREHOLE AND CROSS-SECTION**  
**LOCATION MAP**
