Name/Description: Westview Townhomes

Physical Address: 125 West Highway 22

**-ENVIRONMENTAL ANALYSIS-  
WESTVIEW TOWN HOMES PROJECT,  
JACKSON, WYOMING**

**GEOTECHNICAL INVESTIGATION REPORT  
WEST VIEW TOWNHOMES  
1255 W HIGHWAY 22  
JACKSON, WYOMING**

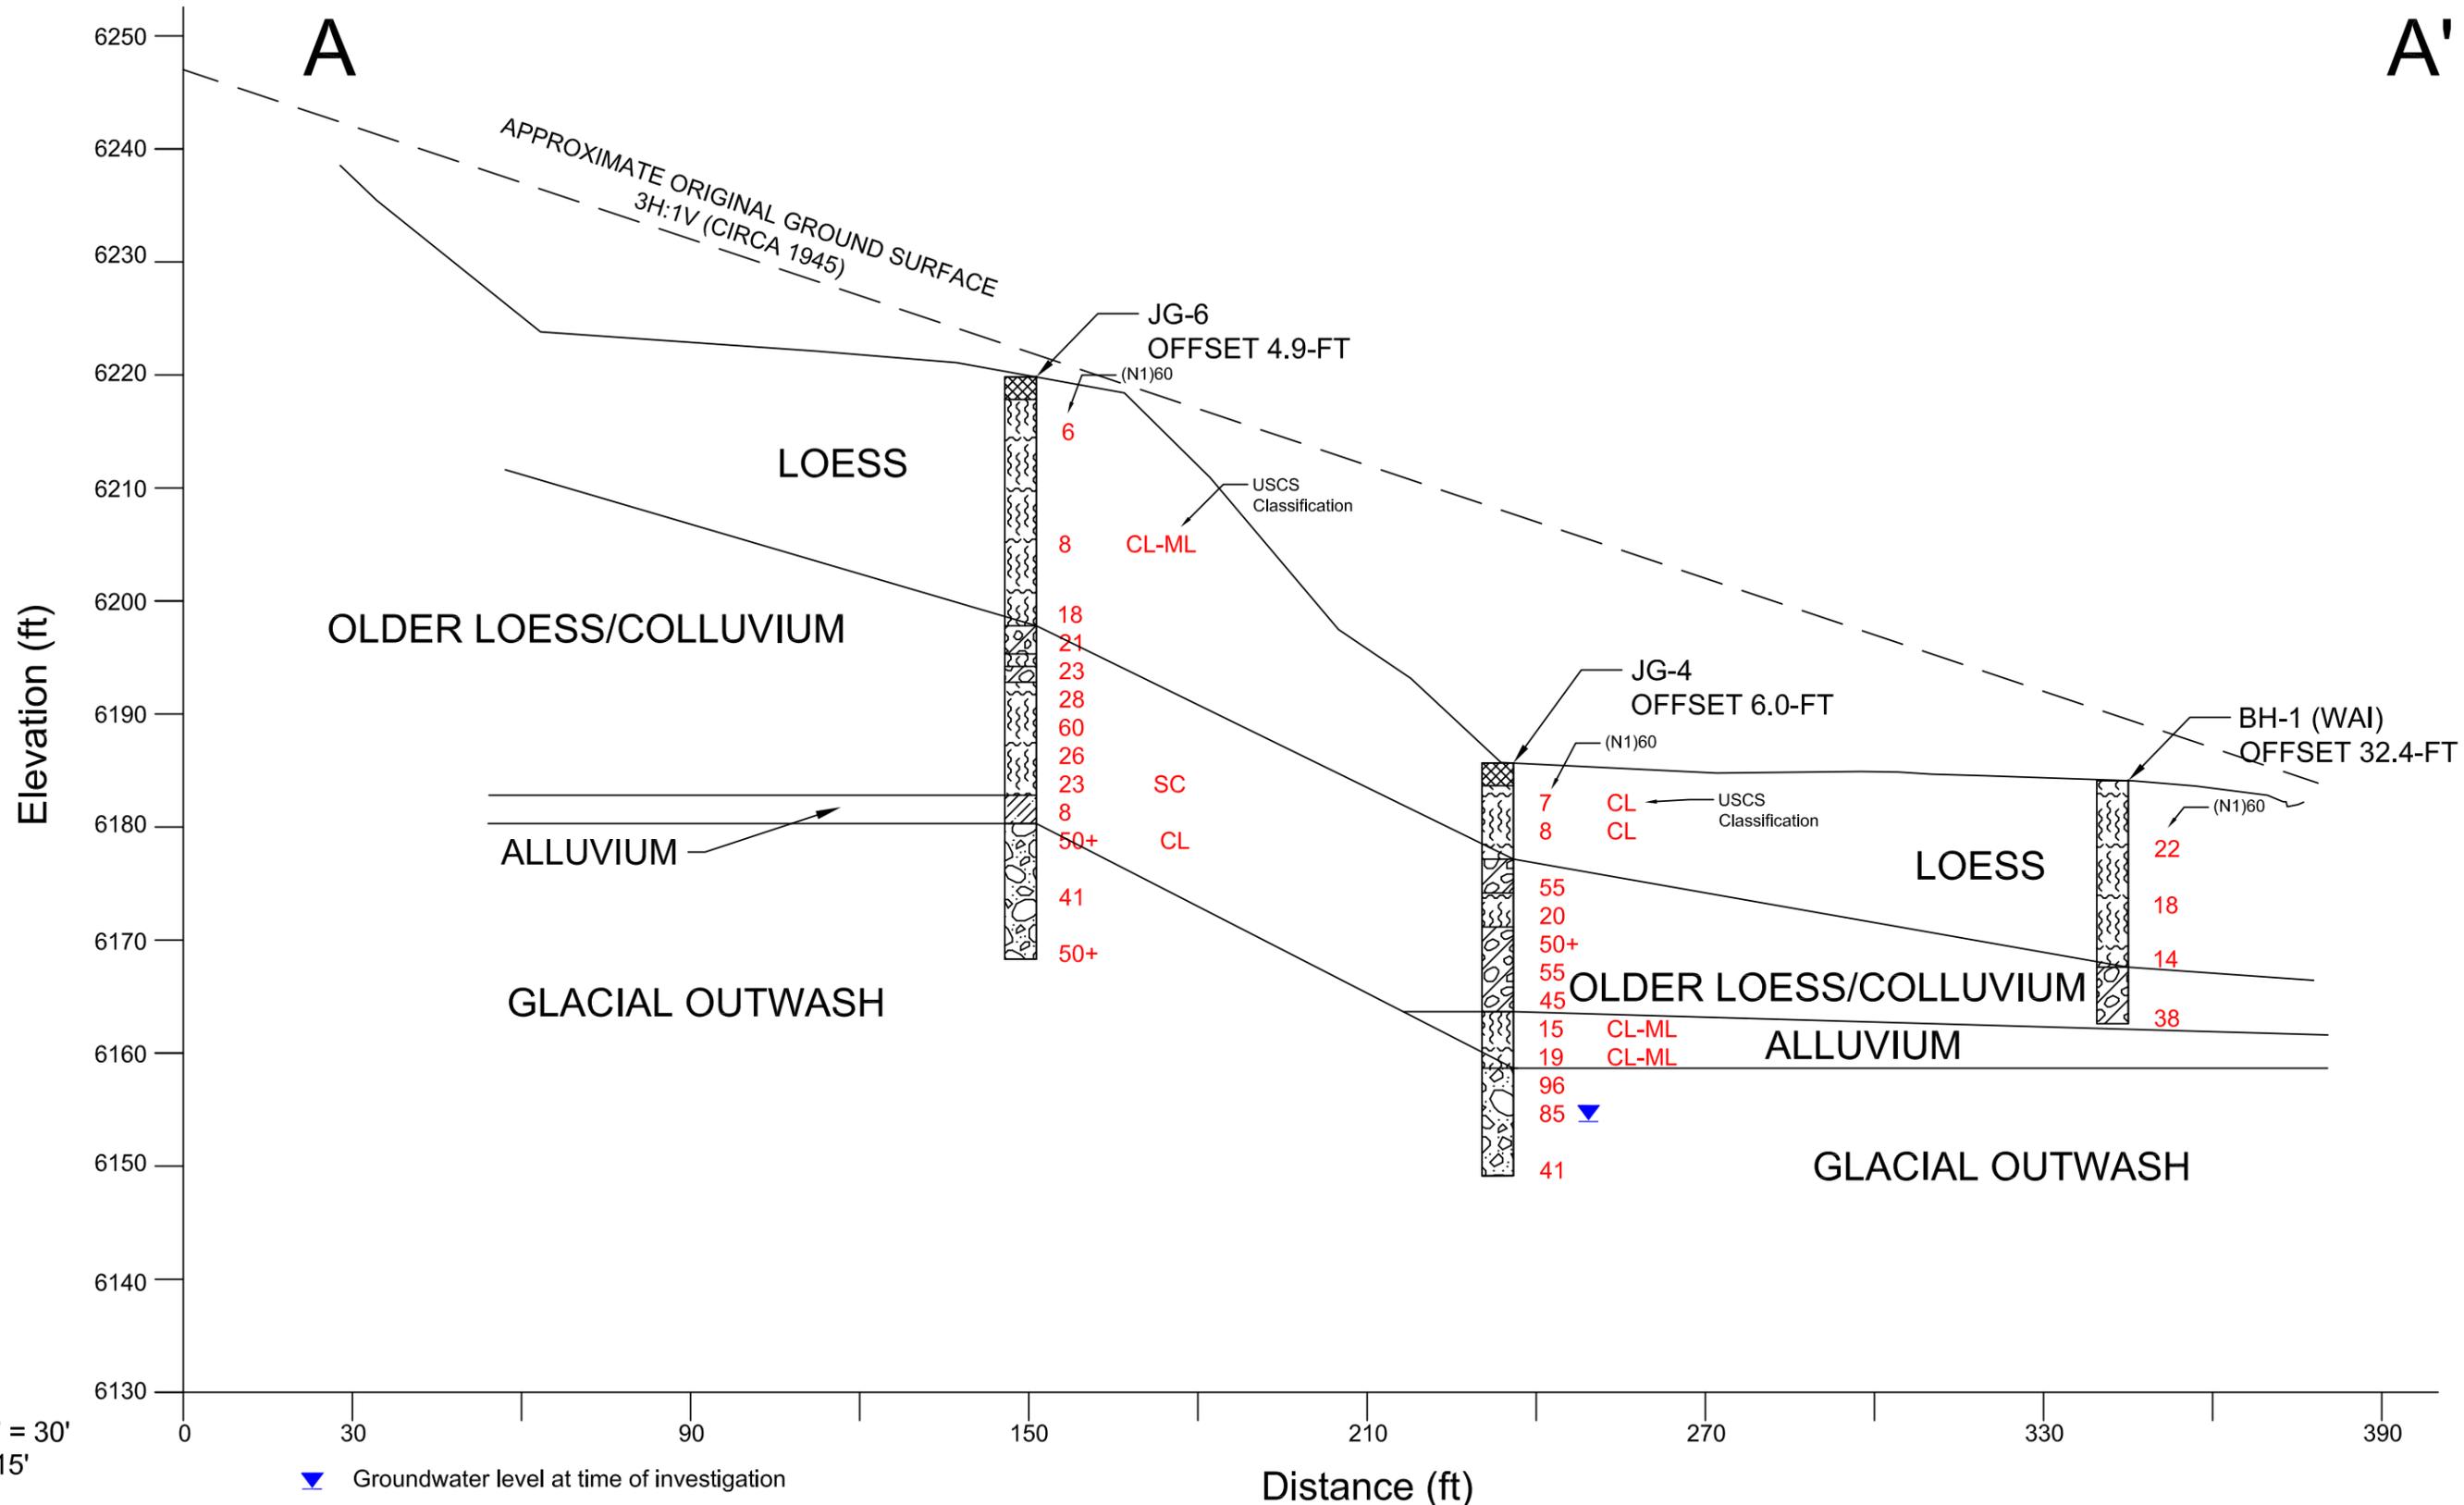
SHEET TITLE:  
**FIGURE 3**  
**GENERALIZED GEOLOGIC**  
**CROSS-SECTION A-A'**

As the geologic cross-sections illustrate, the stony glacial outwash at one time probably had the benched appearance of the terraces along the Snake River in Grand Teton National Park north of Jackson. These terraces were subsequently obscured by deposition of windblown loess and colluvium (gravity deposits from the face of East Gros Ventre Butte). Abrupt steps should be expected between the buried stony glacial outwash terraces. For example, the elevation of the glacial outwash on the upper bench varies by about 8-ft. The outwash was originally level and was subsequently eroded by lateral channel movement, creating a higher terrace. Later erosion and down-cutting lowered the gravel surface an additional 20 to 35 feet (see Figures 3 and 4).

The slope stability analyses were performed using the SLOPE/W stability module of GeoStudio 2012 version 8.15.1.11236, produced by GEO-SLOPE International, Ltd. The Morgenstern-Price limit equilibrium method, which takes into consideration moment and force equilibrium, was used to analyze slope stability. Schematic cross-sections are shown on Figures 3 and 4 and SLOPE/W output figures are presented in Figures 6 through 9.

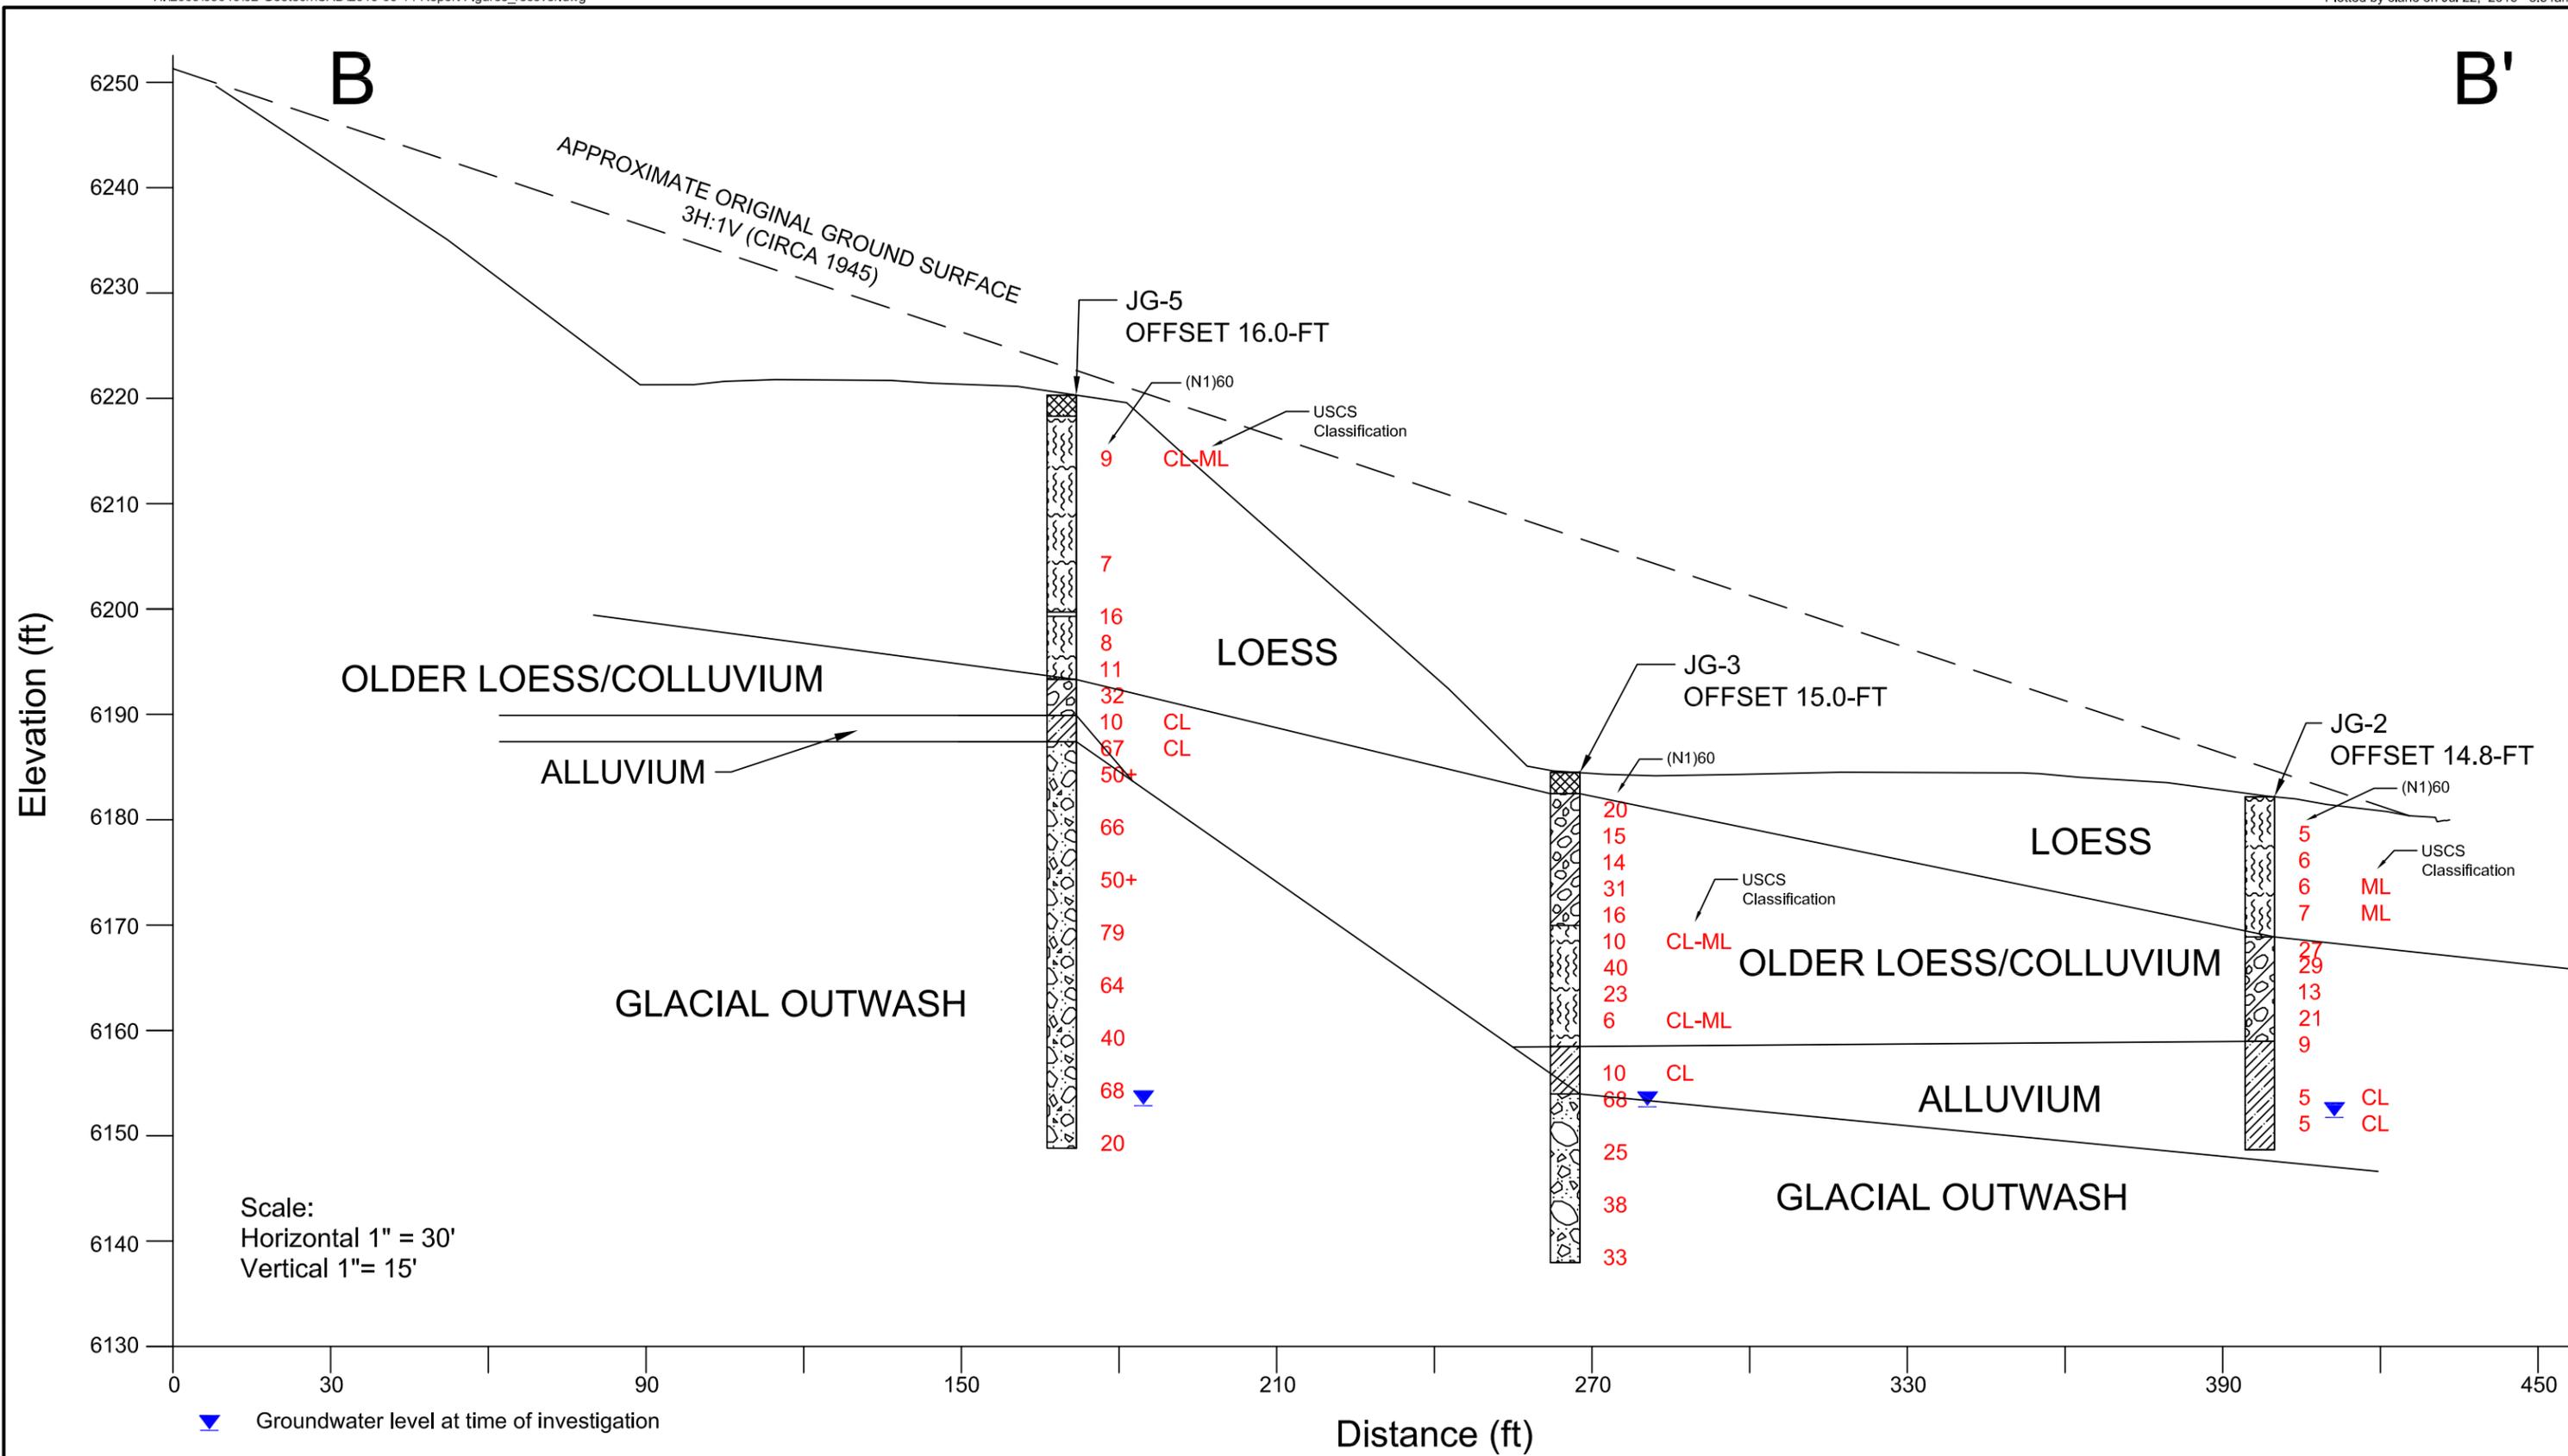
SHEET TITLE:  
**FIGURE 4**  
**GENERALIZED GEOLOGIC**  
**CROSS-SECTION B-B'**

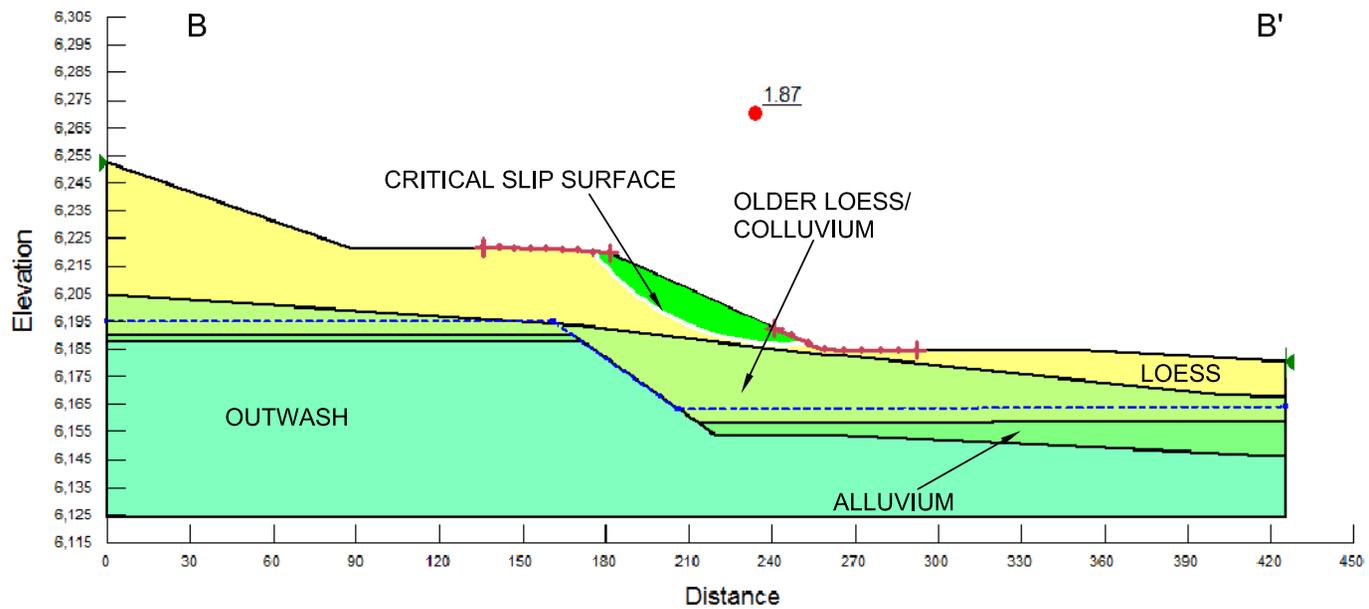
Cross-Section B-B' Existing Conditions - Static Analysis

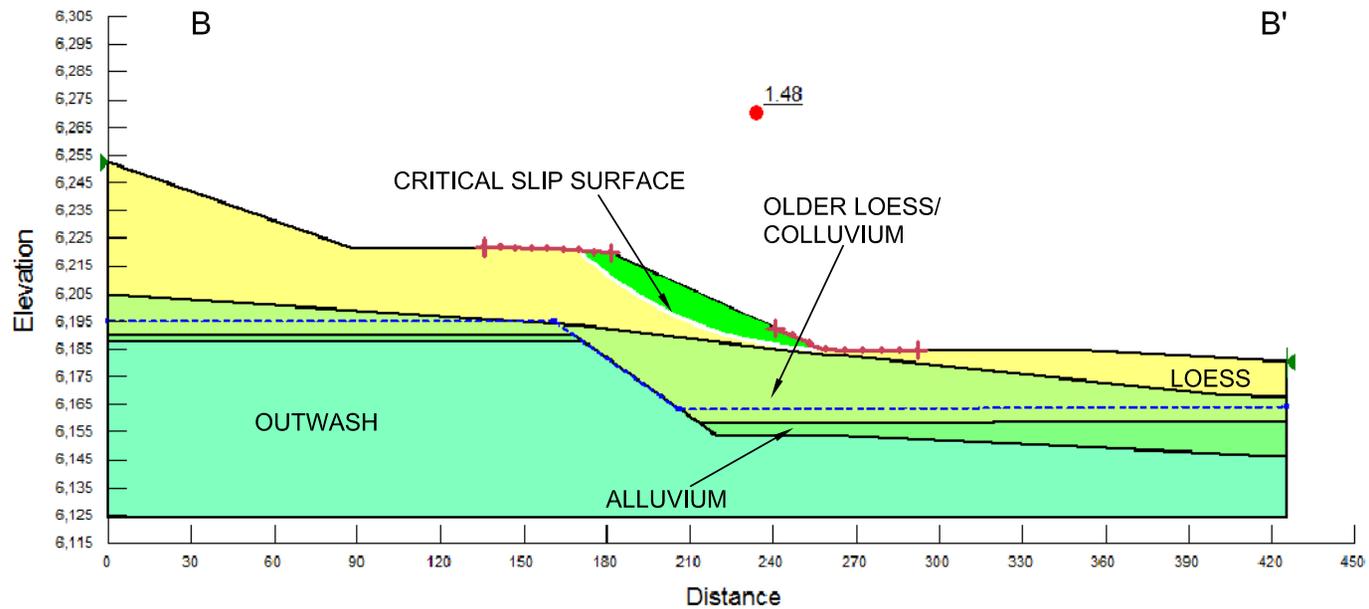
Cross-Section B-B' Existing Conditions - Seismic Analysis

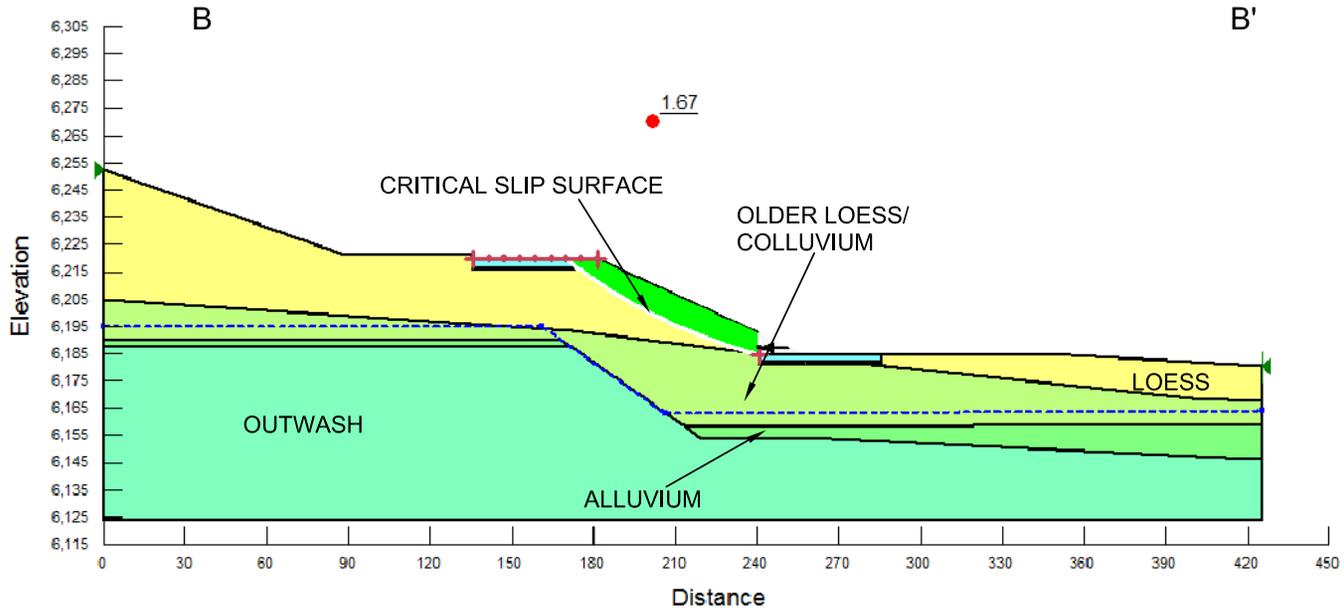
Cross-Section B-B' Post-Construction Conditions - Static Analysis

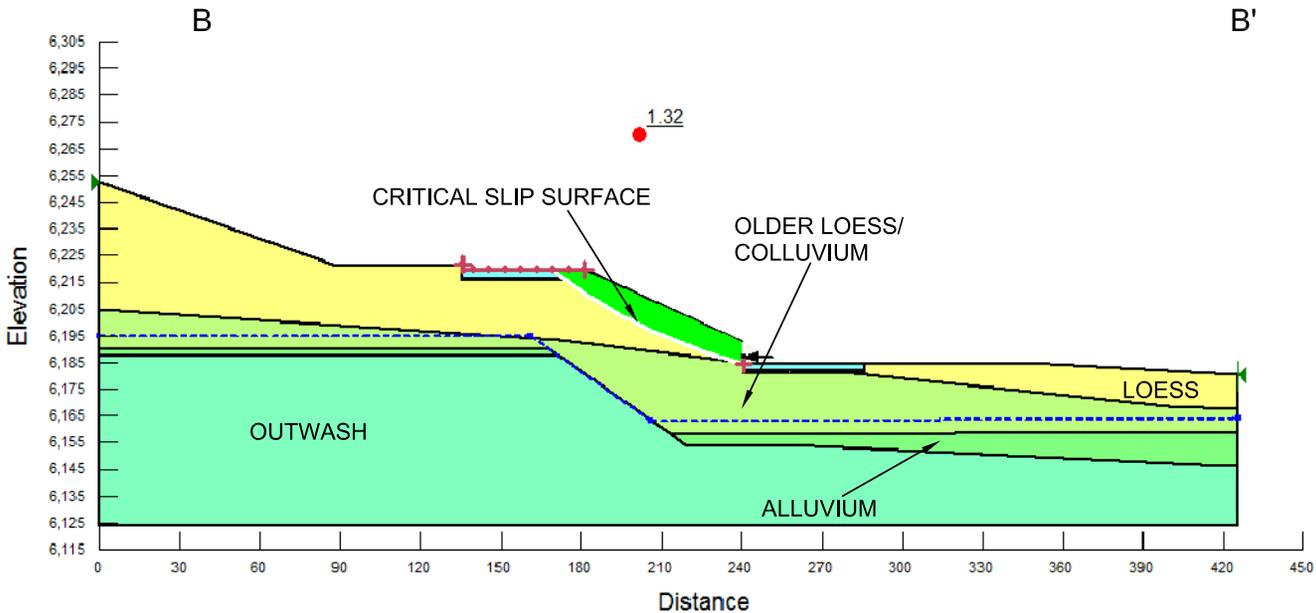
Cross-Section B-B' Post-Construction Conditions - Seismic Analysis

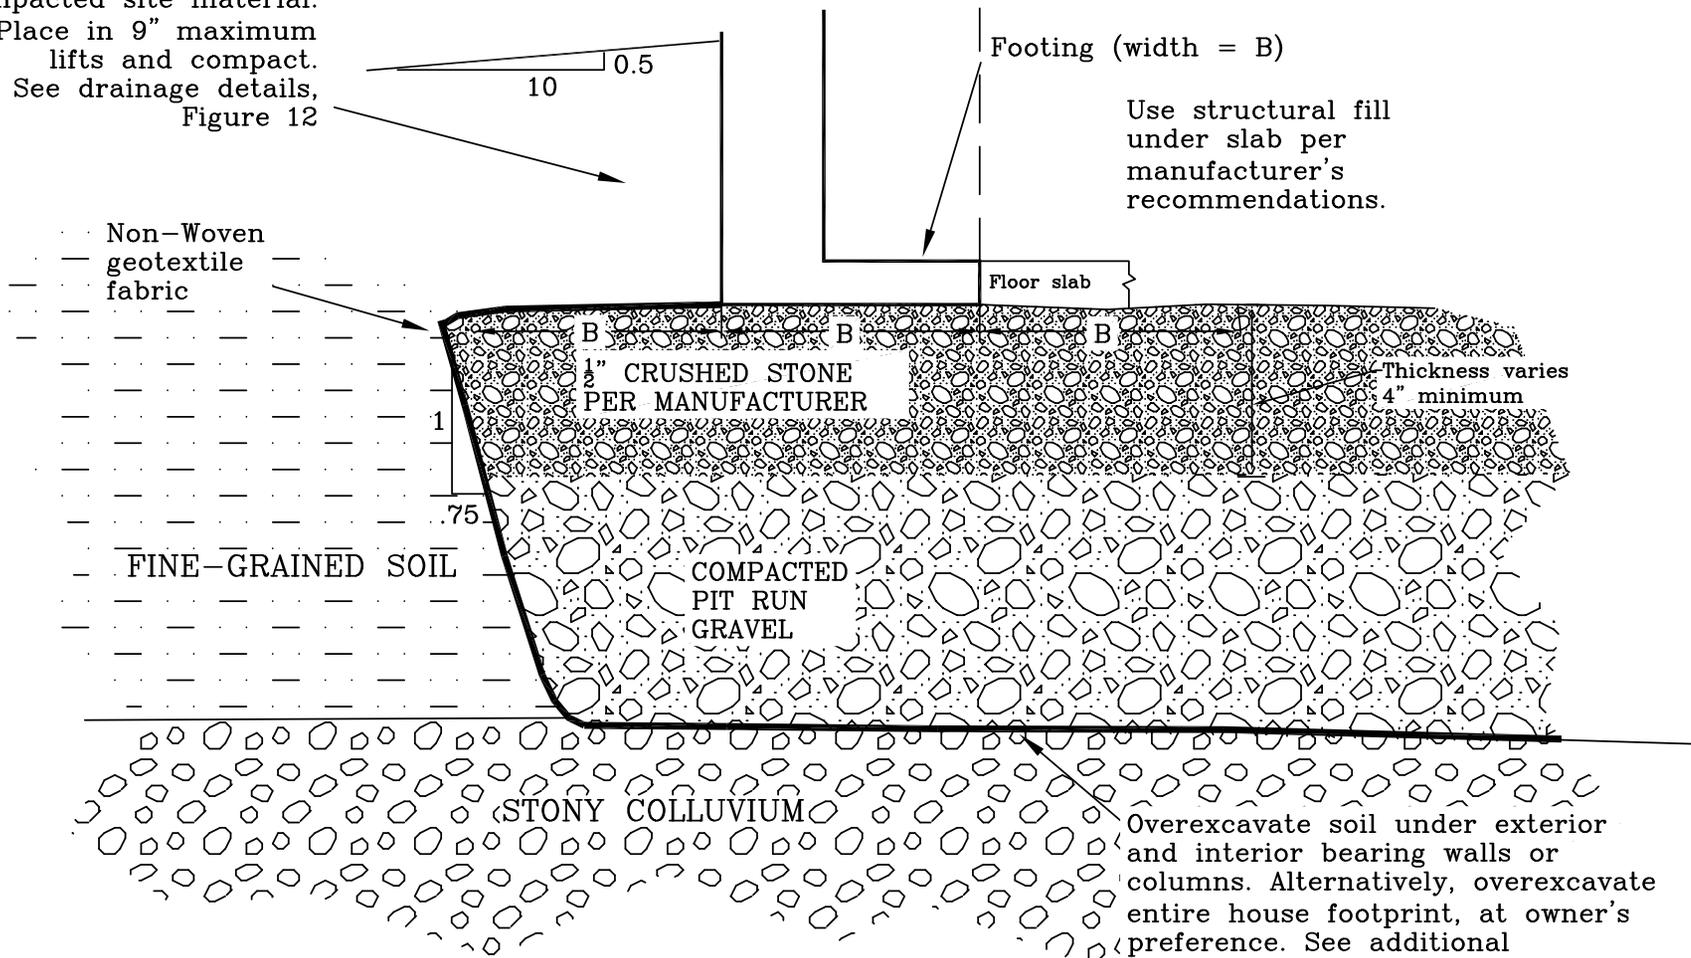
Exterior backfill:  
Compacted site material.  
Place in 9" maximum  
lifts and compact.  
See drainage details,  
Figure 12

Overexcavate soil under exterior and interior bearing walls or columns. Alternatively, overexcavate entire house footprint, at owner's preference. See additional recommendations for interior slab section.

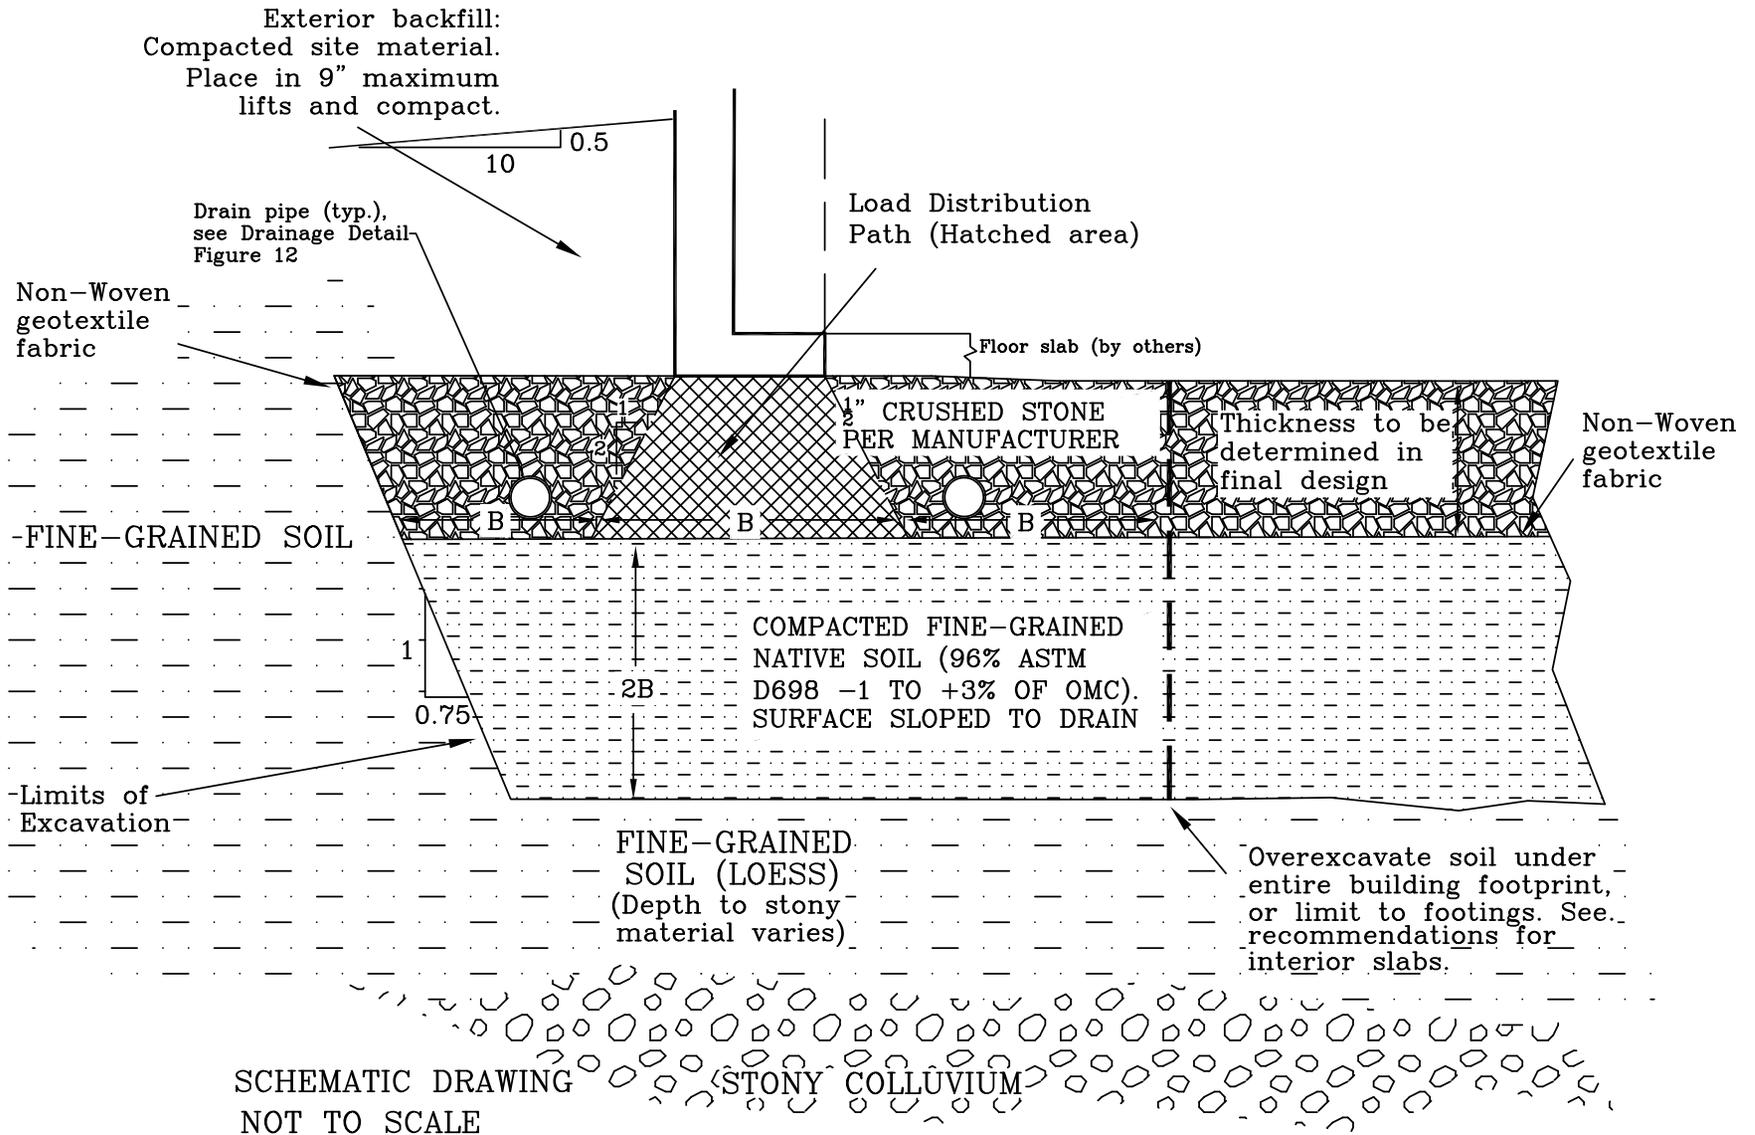
SHEET TITLE:  
**FIGURE 11**  
**OVER-EXCAVATION AND**  
**RE-COMPACTION SCHEMATIC**

Loess should be excavated at least two footing widths ( $2B$ ) from beneath the aggregate and at least one footing width ( $B$ ) on either side of the modified pressure distribution, as shown in Figure 11. This volume is often described as a footing's zone of influence, as foundation loads are estimated to be low enough outside this region to not affect the soil. It may be easier and certainly safer to excavate below the entire footprint of the building (i.e., below both footings and slabs). If the excavation is not extended to the entire footprint of the building, loess under interior slabs-on-grade must be improved as described in Section 7.4.

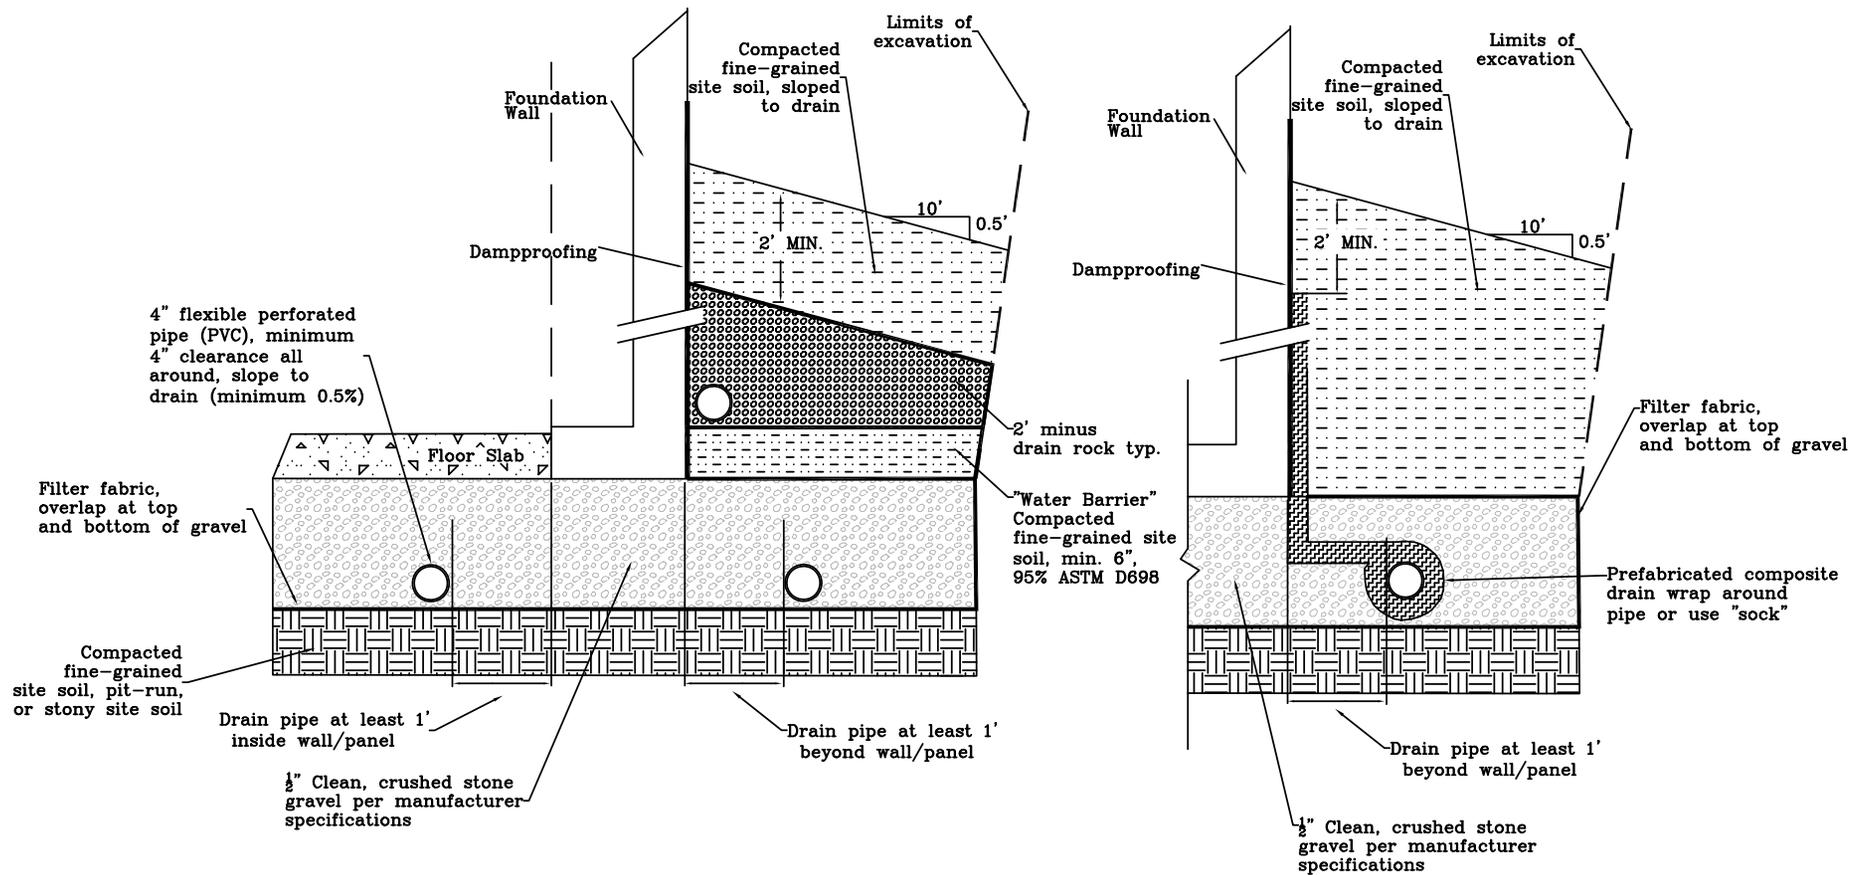
**USING GRAVEL DRAIN AND FILTER**

**USING PREFABRICATED COMPOSITE DRAIN**

SHEET TITLE:  
**FIGURE 12**  
**FOUNDATION DRAINAGE**  
**DETAILS**

*Foundation and sub-slab drain options have been described in Section 7.3 of the Geotechnical Report and depicted in Figure 12. The Superior Wall® foundation system recommends a fairly robust sub-slab drainage system that we have incorporated into our typical recommendations. Drain layers will be placed on top of compacted native loess, forming a low permeable barrier between the drain layer and the underlying native loess. The Report notes that “management of water at this site is extremely important” and recommends JG review final plans to ensure that site drainage is properly accounted for.*

Two drainage alternatives for frost walls or basement walls are illustrated in Figure 12. Water will be kept separate from the sub-slab drainage system recommended by the Superior Walls® manufacturer with the use of a compacted fine-grained water barrier. The two options are described as follows:

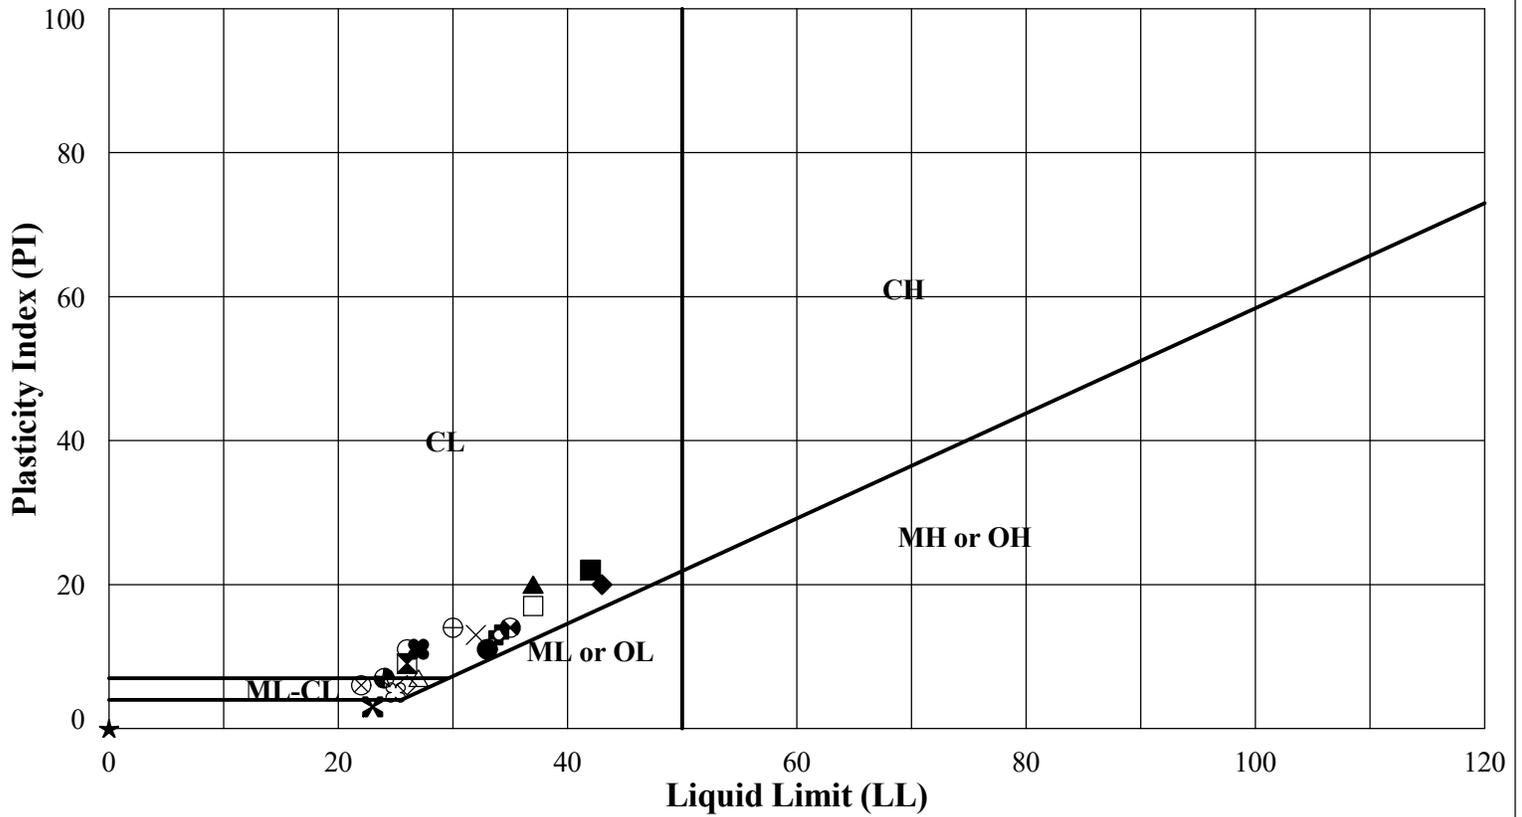
Legend	Boring	Sample No.	Depth	LL	PL	PI	P 200, %	MC	Classification
●	JG-1	D7	17.5' to 19.0'	33	22	11	65.0	24.5%	CL
⊠	JG-1	D8	20.0' to 21.5'	26	17	9	61.0	13.2%	CL
▲	JG-1	D11	27.5' to 29.0'	37	17	20	80.6	21.6%	CL
★	JG-2	D3	7.5' to 9.0'	NP	NP	NP	96.0	13.5%	ML
⊗	JG-2	D4	10.0' to 11.5'	23	20	3	93.0	12.7%	ML
⊕	JG-2	D10	27.5' to 29.0'	34	21	13	93.0	32.9%	CL
○	JG-2	D11	30.0' to 31.5'	26	15	11	55.9	27.9%	CL
△	JG-3	D6	15.0' to 16.5'	27	20	7	79.4	26.4%	CL-ML
⊗	JG-3	D9	22.5' to 24.0'	22	16	6	84.9	22.6%	CL-ML
⊕	JG-3	D10	27.5' to 29.0'	30	16	14	87.0	26.8%	CL
□	JG-4	D1	2.5' to 4.0'	37	20	17	94.4	28.4%	CL
⊗	JG-4	D2	5.0' to 6.5'	35	21	14	96.6	29.0%	CL
⊕	JG-4	D8	22.5' to 24.0'	24	17	7	87.0	20.9%	CL-ML
☆	JG-4	D9	25.0' to 27.5'	24	17	7	81.0	15.7%	CL-ML
⊗	JG-5	D1	5.0' to 7.5'	25	20	5	87.3	25.5%	CL-ML
■	JG-5	D7	30.0' to 31.5'	42	20	22	75.0	25.2%	CL
◆	JG-5	D8	32.5' to 33.0'	43	23	20	79.5	30.0%	CL
◇	JG-6	D2	15.0' to 16.5'	26	20	6	79.7	13.8%	CL-ML

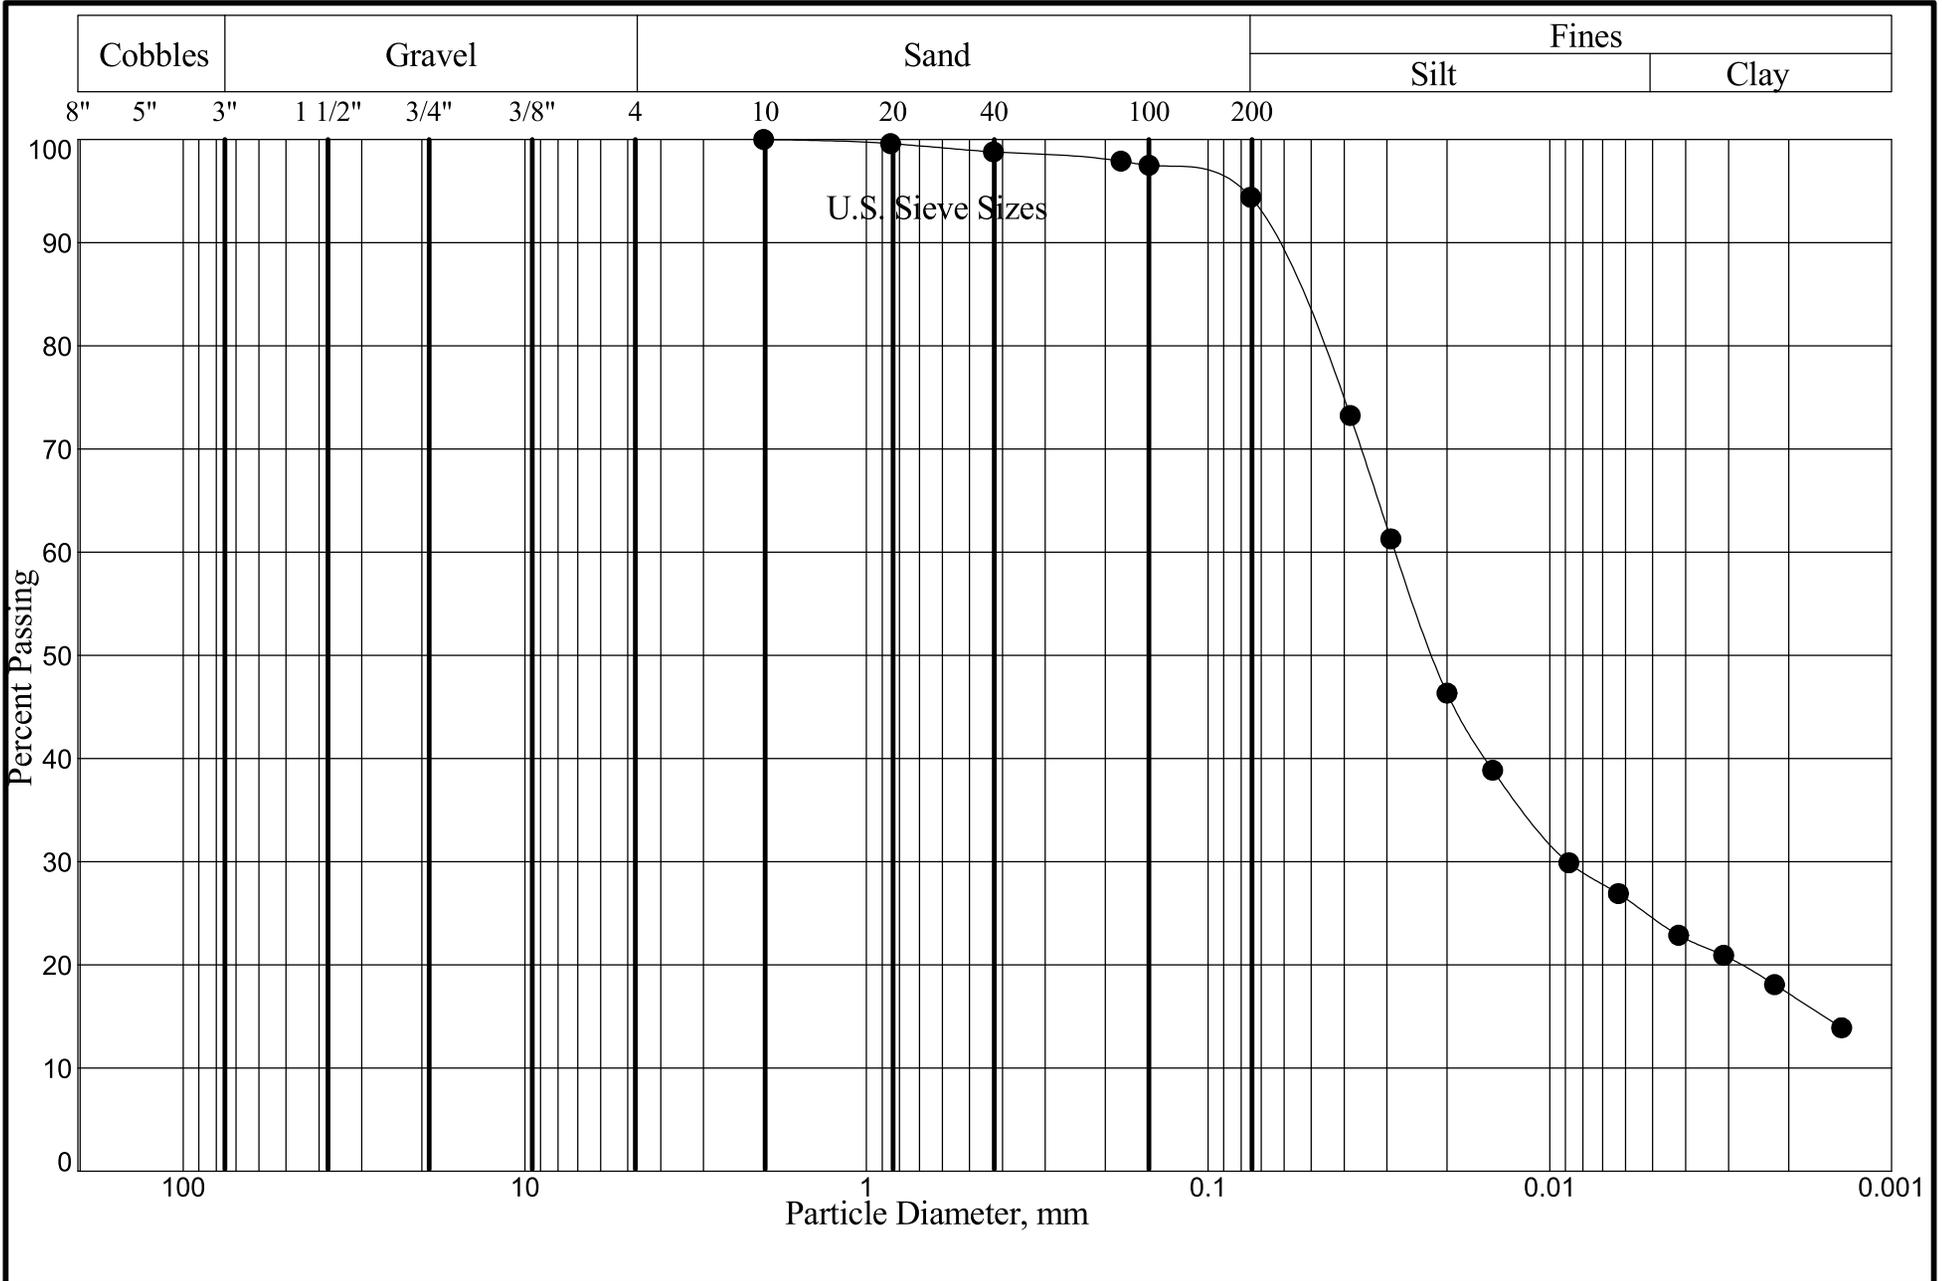
### Grain Size Analysis Curve

% Gravel:	0.0	LL:	37
% Sand:	5.6	PL:	20
% Silt:	69.8	PI:	17
% Clay:	24.6	MC:	28.4%
Class:	CL	SG:	2.600
LEAN CLAY
