Name/Description: Westview Townhomes

Physical Address: 125 West Highway 22

**-ENVIRONMENTAL ANALYSIS-  
WESTVIEW TOWN HOMES PROJECT,  
JACKSON, WYOMING**

**GEOTECHNICAL INVESTIGATION REPORT  
WEST VIEW TOWNHOMES  
1255 W HIGHWAY 22  
JACKSON, WYOMING**

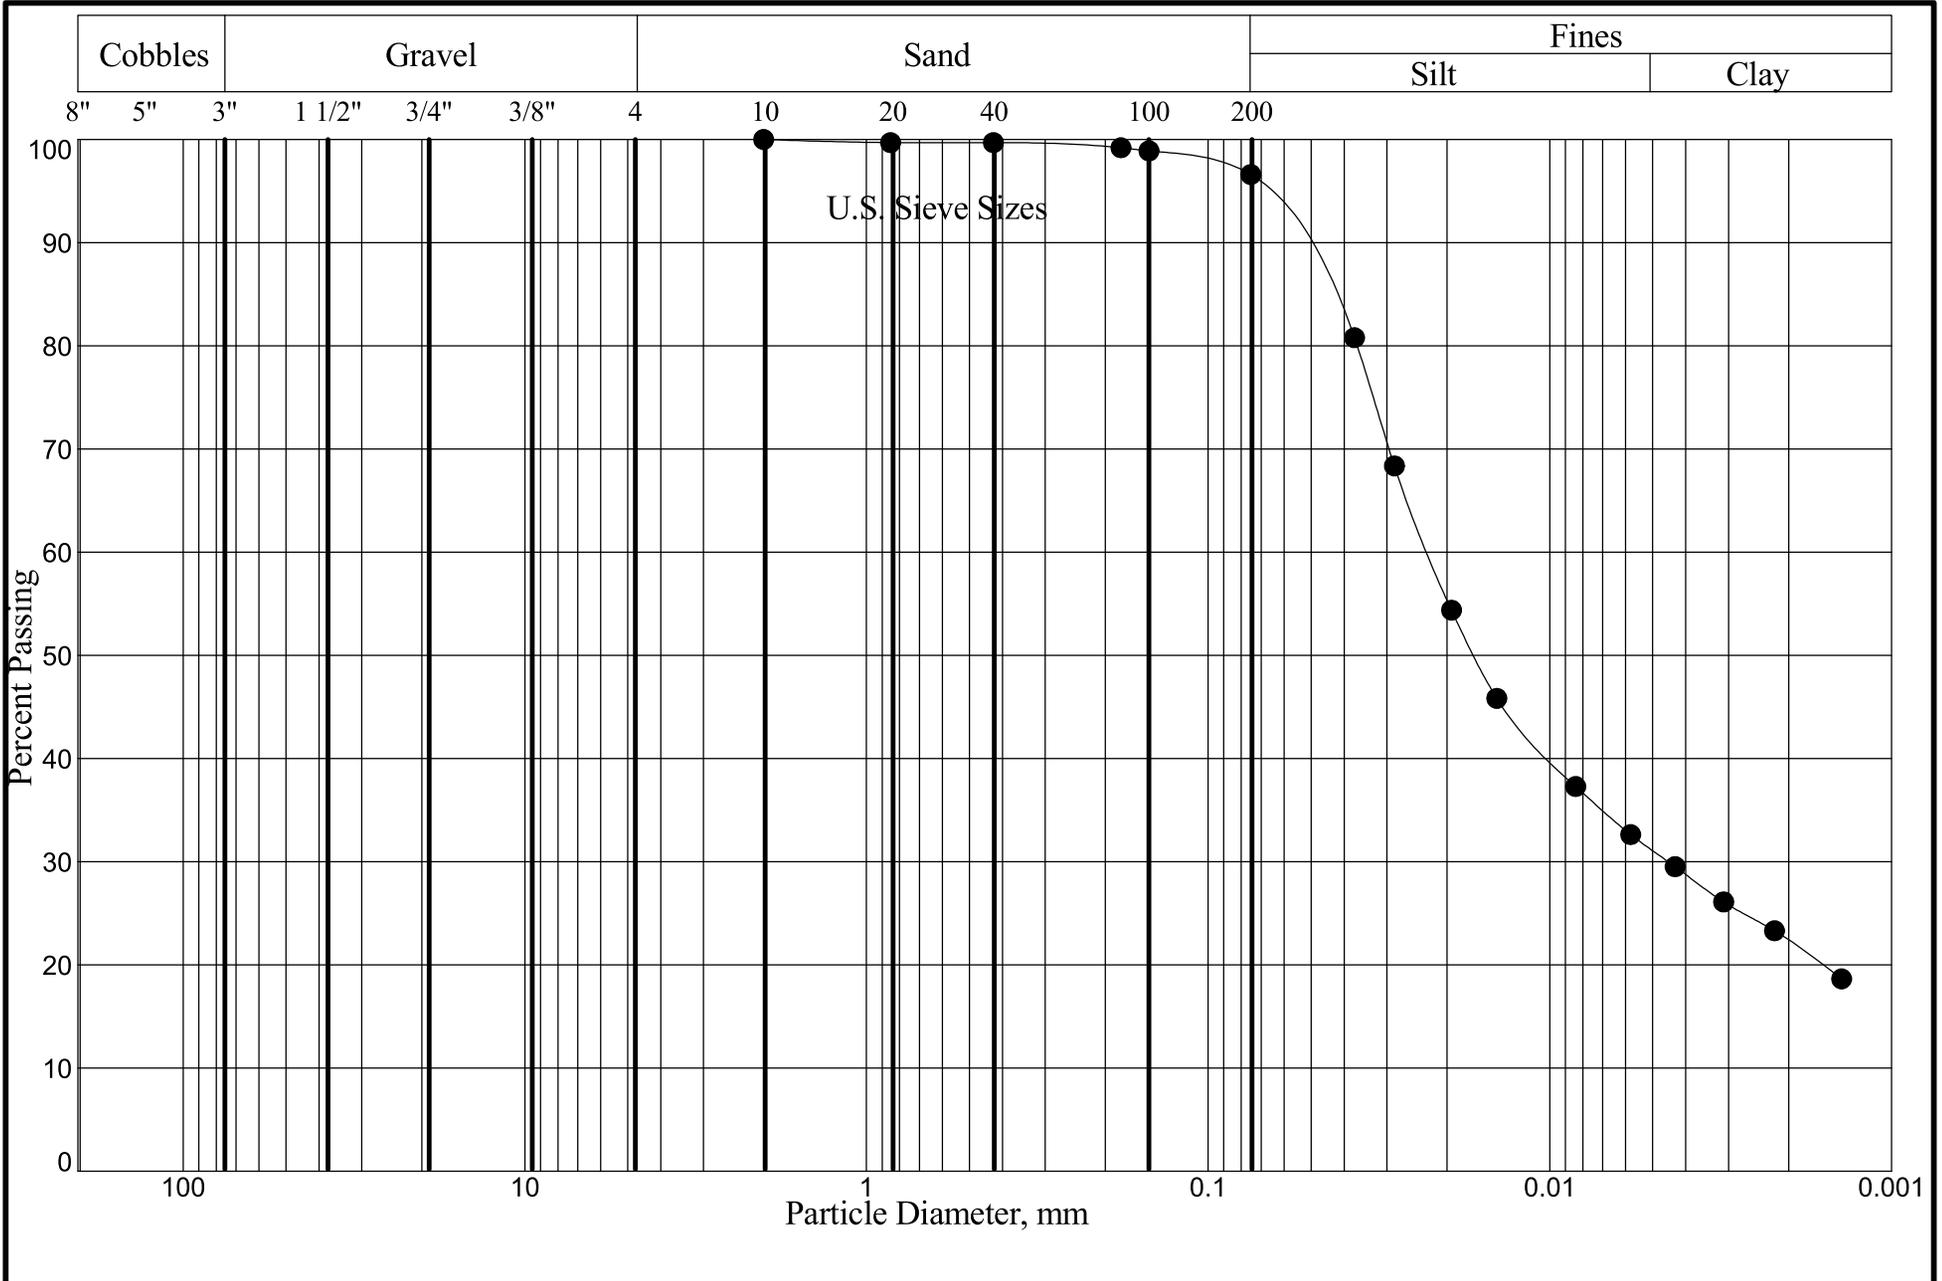
### Grain Size Analysis Curve

% Gravel:	0.0	LL:	35
% Sand:	3.4	PL:	21
% Silt:	65.5	PI:	14
% Clay:	31.1	MC:	29.0%
Class:	CL	SG:	2.600
LEAN CLAY

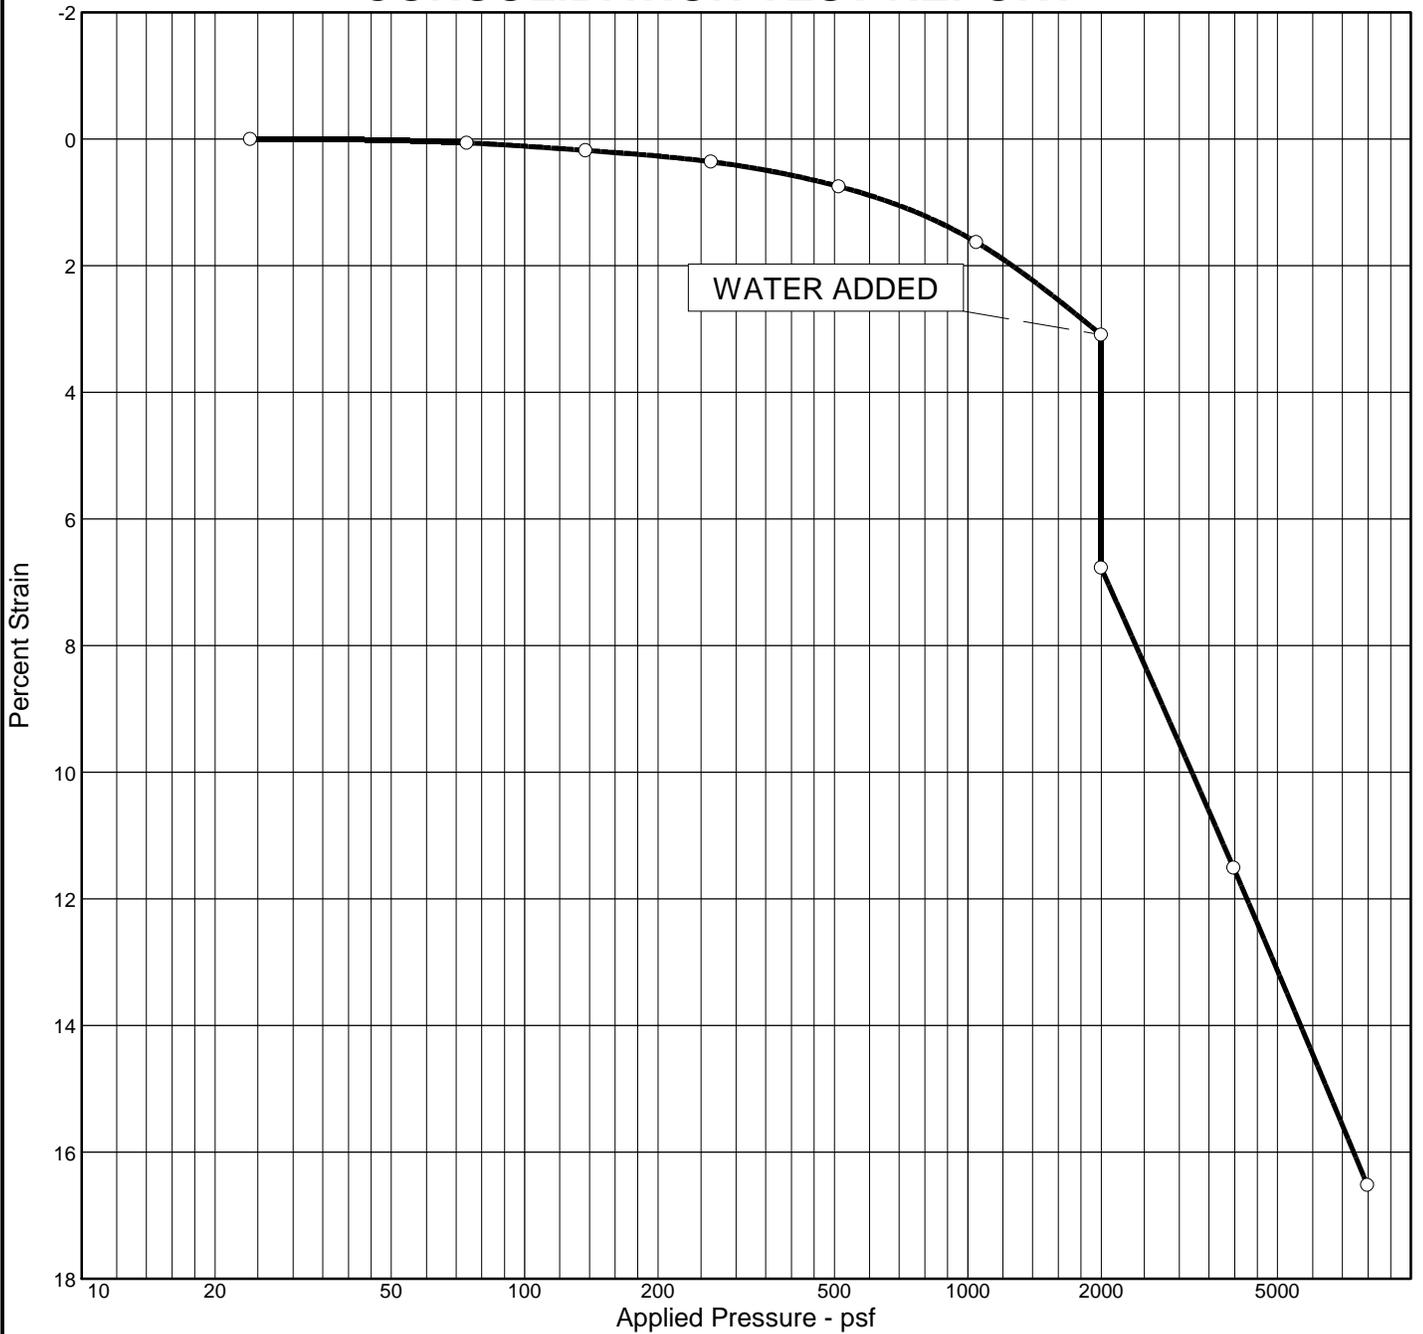
# CONSOLIDATION TEST REPORT

Natural		Dry Dens. (pcf)	LL	PI	Sp. Gr.	Overburden (psf)	P <sub>c</sub> (psf)	C <sub>c</sub>	C <sub>r</sub>	Swell Press. (psf)	Clpse. %	e <sub>0</sub>
Sat.	Moist.											
41.7 %	22.3 %	68.5			2.65	712	965	0.40			3.7	1.415

MATERIAL DESCRIPTION	USCS	AASHTO
Silt (ML), trace pinholes, FeO, and clay lenses, orangish brown, moist, loose

<p><b>Project No.</b> 15-3404L      <b>Client:</b> Jorgensen Associates, PC</p> <p><b>Project:</b> Jorgensen 09040.01.30, West View Townhomes</p> <p><b>Location:</b> JG-4 U1    Depth 7.5 - 8.5 ft</p> <p style="text-align: center;">CONSOLIDATION TEST REPORT</p> <p style="text-align: center; font-size: 1.5em; font-weight: bold;">SK GEOTECHNICAL CORP.</p>	<p><b>Remarks:</b></p>     <p style="text-align: right;">Figure</p>
--	--

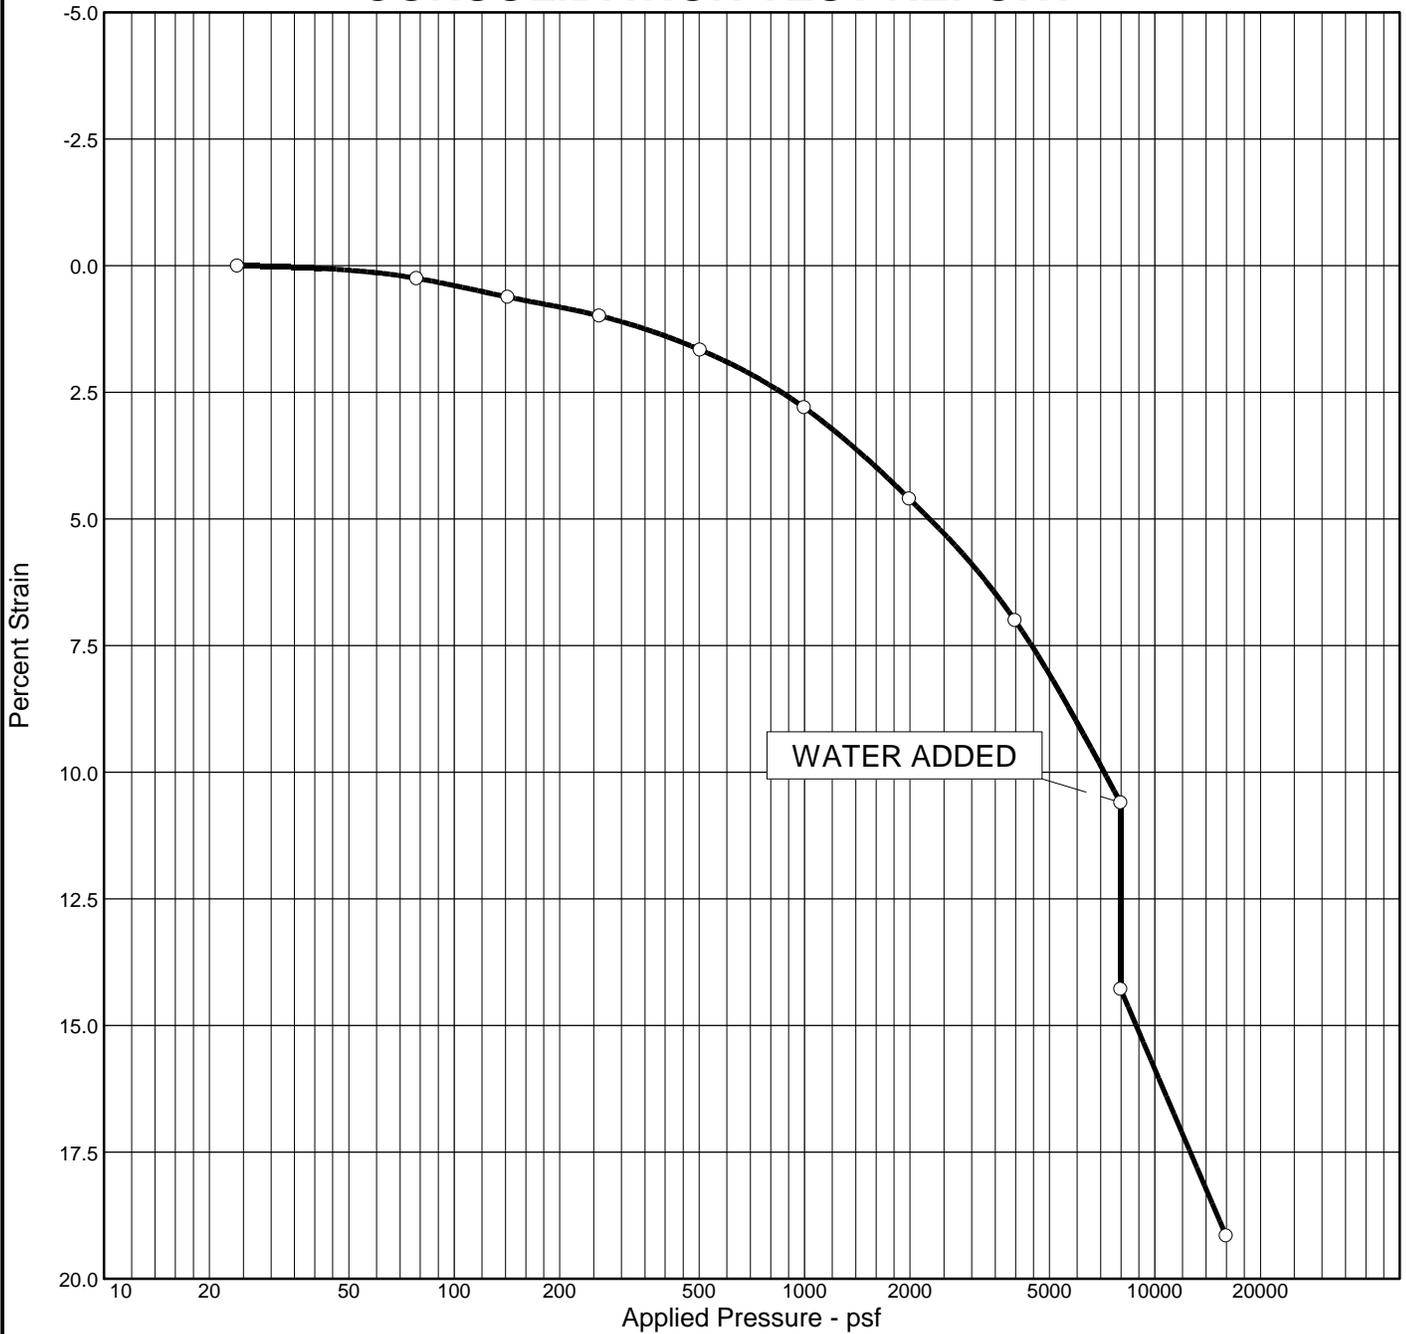
# CONSOLIDATION TEST REPORT

Natural		Dry Dens. (pcf)	LL	PI	Sp. Gr.	Overburden (psf)	P <sub>C</sub> (psf)	C <sub>c</sub>	C <sub>r</sub>	Swell Press. (psf)	Clpse. %	e <sub>0</sub>
Sat.	Moist.											
32.3 %	13.7 %	77.8			2.65	752	1566	0.34			3.7	1.126

MATERIAL DESCRIPTION	USCS	AASHTO
Silt (ML), trace pinholes and silt stone, orangish brown, moist, loose

<p><b>Project No.</b> 15-3404L      <b>Client:</b> Jorgensen Associates, PC</p> <p><b>Project:</b> Jorgensen 09040.01.30, West View Townhomes</p> <p><b>Location:</b> JG-6 U1    Depth 7.5 - 8.5 ft</p> <p style="text-align: center;">CONSOLIDATION TEST REPORT</p> <p style="text-align: center; font-size: 1.5em; font-weight: bold;">SK GEOTECHNICAL CORP.</p>	<p><b>Remarks:</b></p> <p style="text-align: right; font-weight: bold;">Figure</p>
--	--

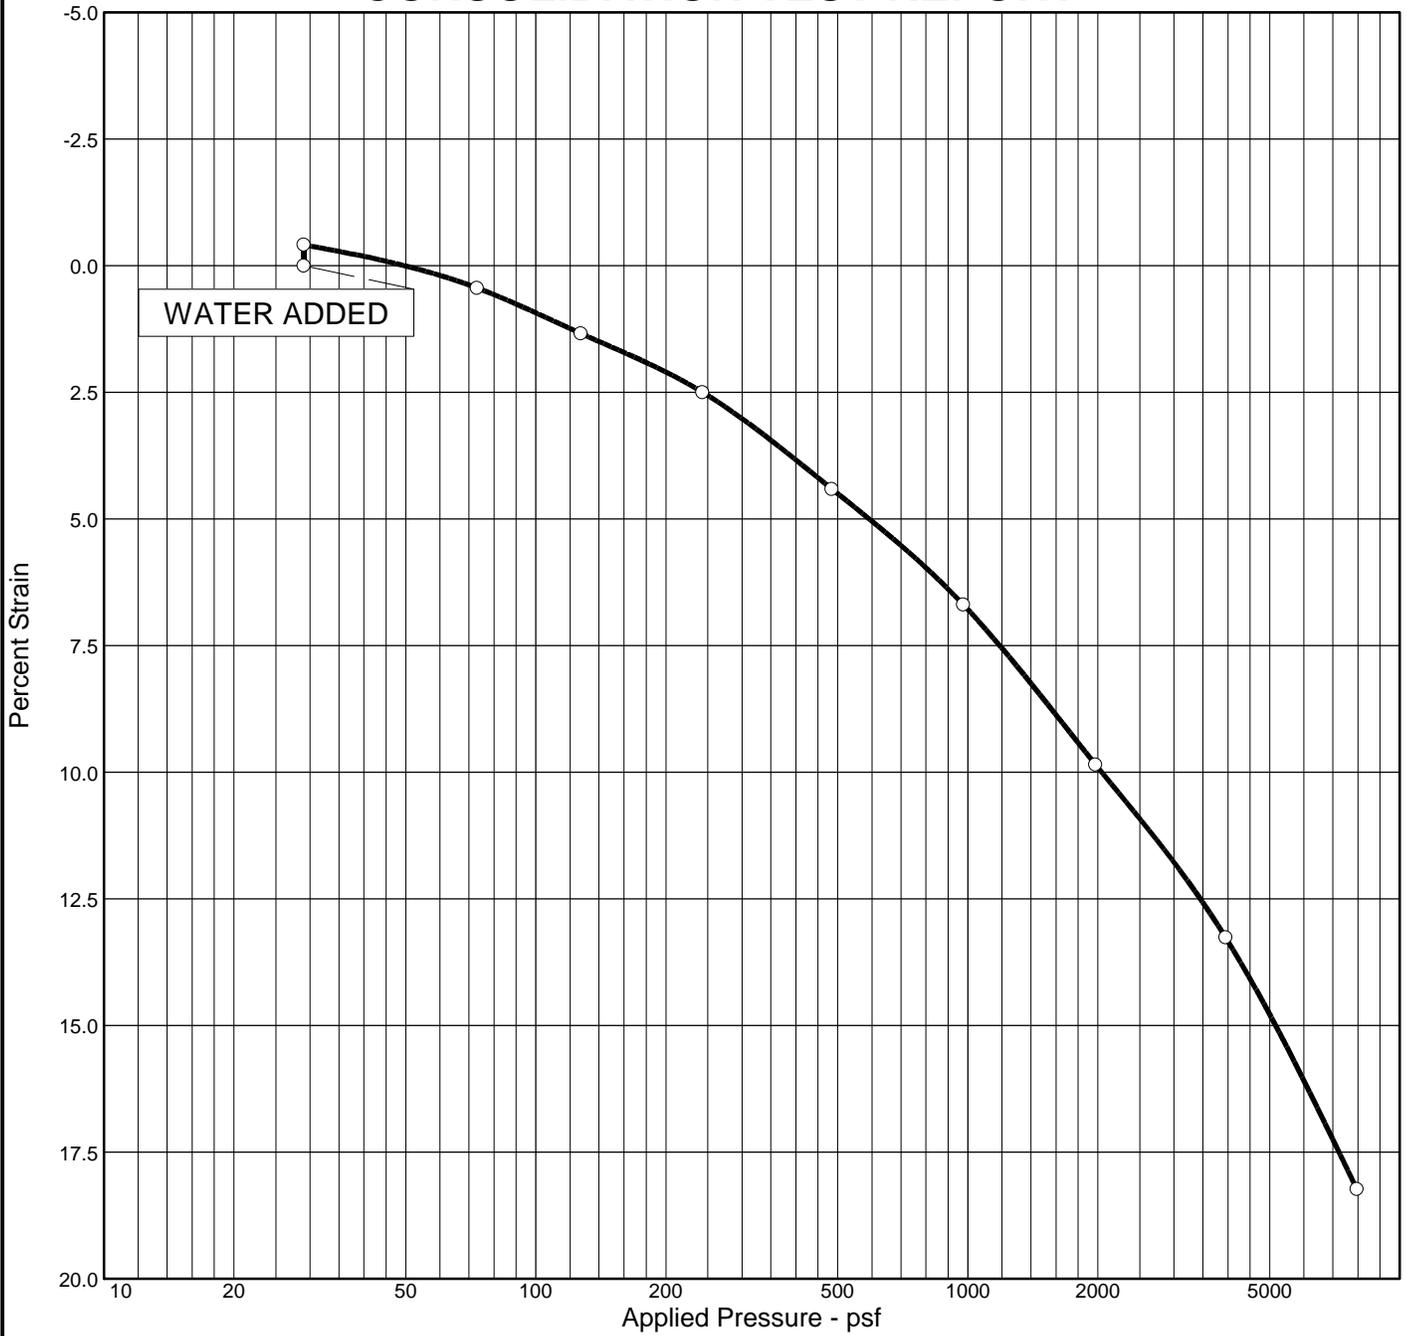
# CONSOLIDATION TEST REPORT

Natural		Dry Dens. (pcf)	LL	PI	Sp. Gr.	Overburden (psf)	P <sub>c</sub> (psf)	C <sub>c</sub>	C <sub>r</sub>	Swell Press. (psf)	Swell %	e <sub>0</sub>
Sat.	Moist.											
30.2 %	14.4 %	73.1			2.65	920	1475	0.38		50	0.4	1.262

<b>MATERIAL DESCRIPTION</b>	<b>USCS</b>	<b>AASHTO</b>
Silt (ML), trace pinholes, FeO, and clay lenses, orangish brown, moist, loose

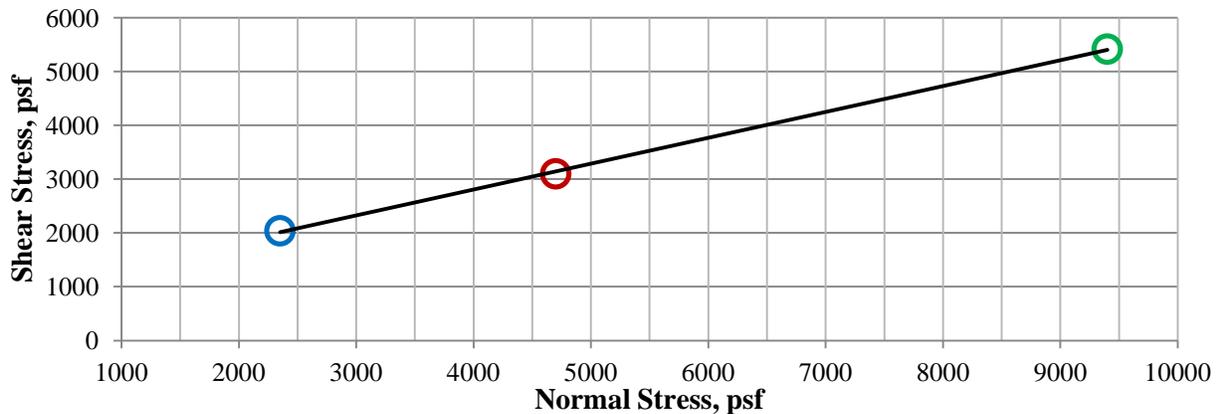
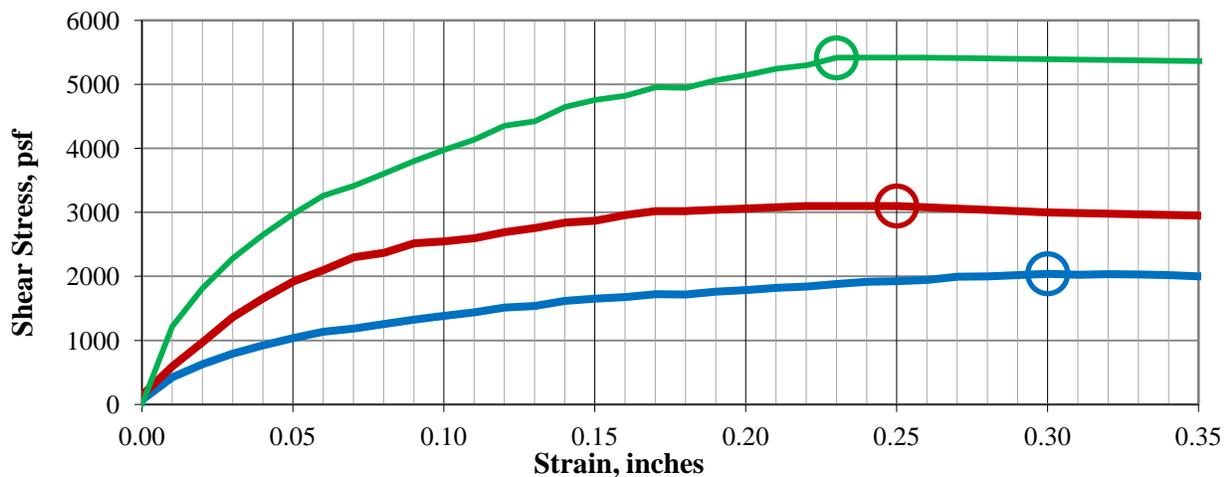
## Direct Shear of Soils Under Consolidated Drained Conditions, ASTM D3080

**Boring:** JG-6 U3                      **Depth:** 39 - 40 '                      **Type:** remolded  
**Description:** Lean clay (CL) with silt, trace sand and salts, orangish brown, moist, soft

Normal Stress, psf	Initial Moisture, %	Final Moisture, %	Consol + Collapse, %	Final Wet Density, pcf	Final Dry Density, pcf	Max Shear Stress, psf	Failure Strain, %
<b>2350</b>	19.0	6.2	11.8	88.0	82.9	<b>2041</b>	<b>12.4</b>
<b>4700</b>	19.0	5.3	15.7	91.3	86.7	<b>3100</b>	<b>10.3</b>
<b>9400</b>	19.0	4.9	19.9	95.7	91.2	<b>5415</b>	<b>9.5</b>

Friction Angle,  $\phi^\circ$  **25.7**      Cohesion, C, psf **883**      Strain rate, %/hour **1.03**

A remolded sample of alluvial clay was tested for effective shear strength parameters using direct shear. The testing yielded  $\phi' = 25.7^\circ$  and  $c' = 883$  psf. A correlation between the alluvial clay’s plasticity index (PI) and peak effective friction angle (Ladd et al, 1977) indicates the soil is fairly strong. Using the maximum PI (22 from sample JG-5 D7) yields  $\phi' = 30^\circ$ . As discussed in Section 5.2 below, critical slip surfaces (those with the lowest factors of safety, shown on Figures 6, 7, 8, and 9) did not extend deep enough to be affected by the shear strength of the clay.

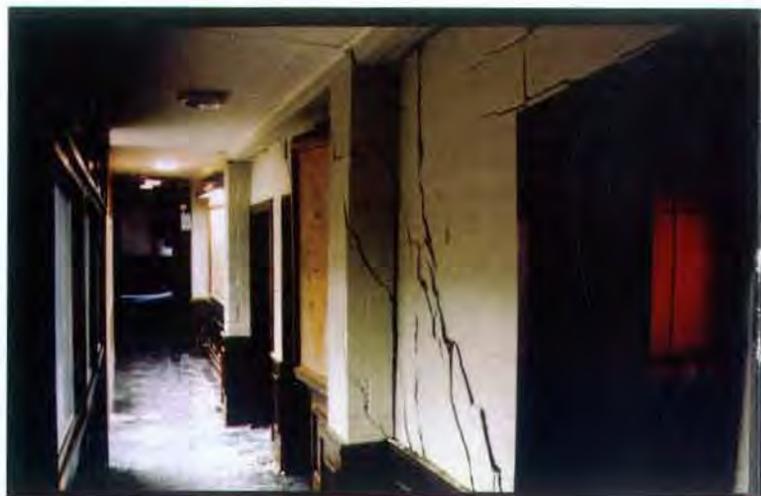
Figure 4. Building damage due to loess collapse.

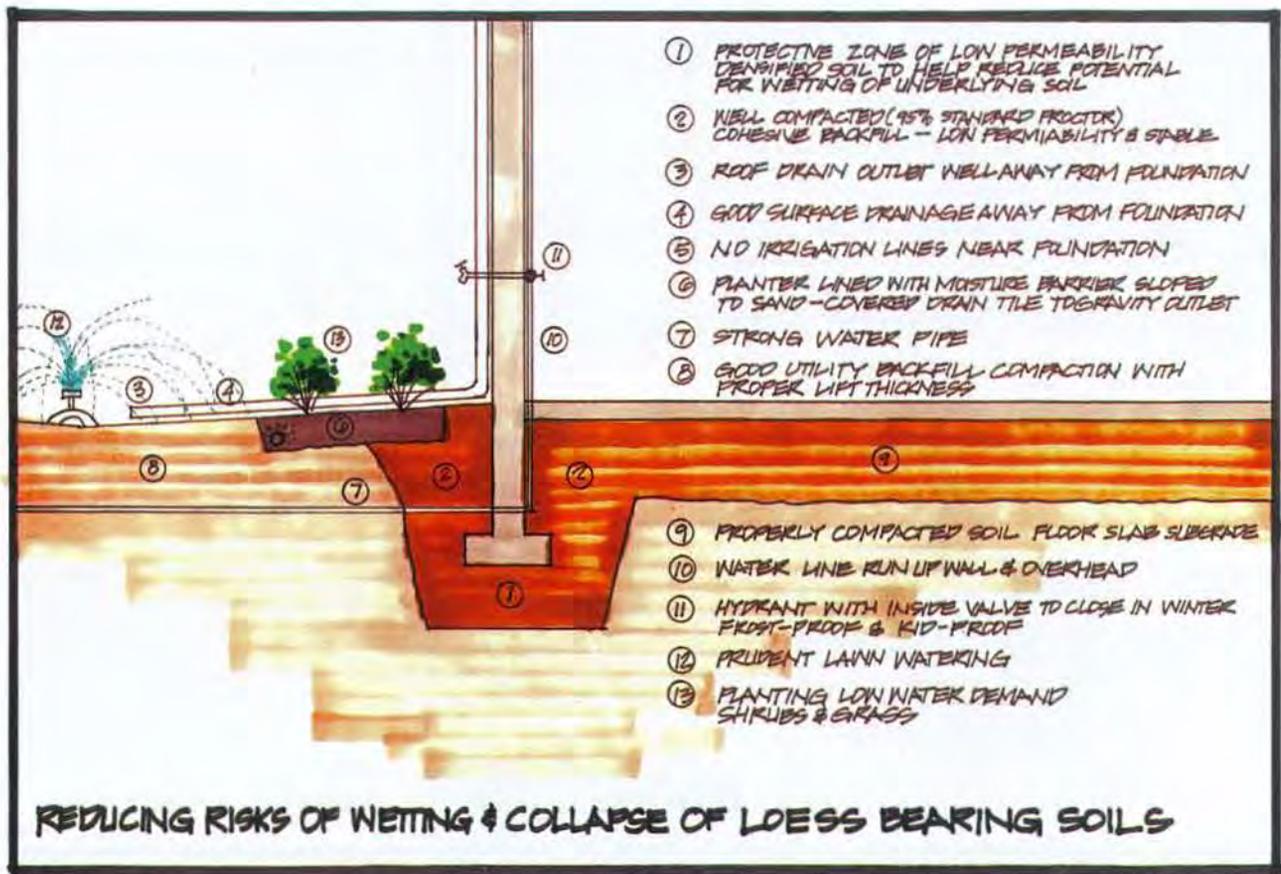
Figure 5. Common measures used to reduce wetting risks.

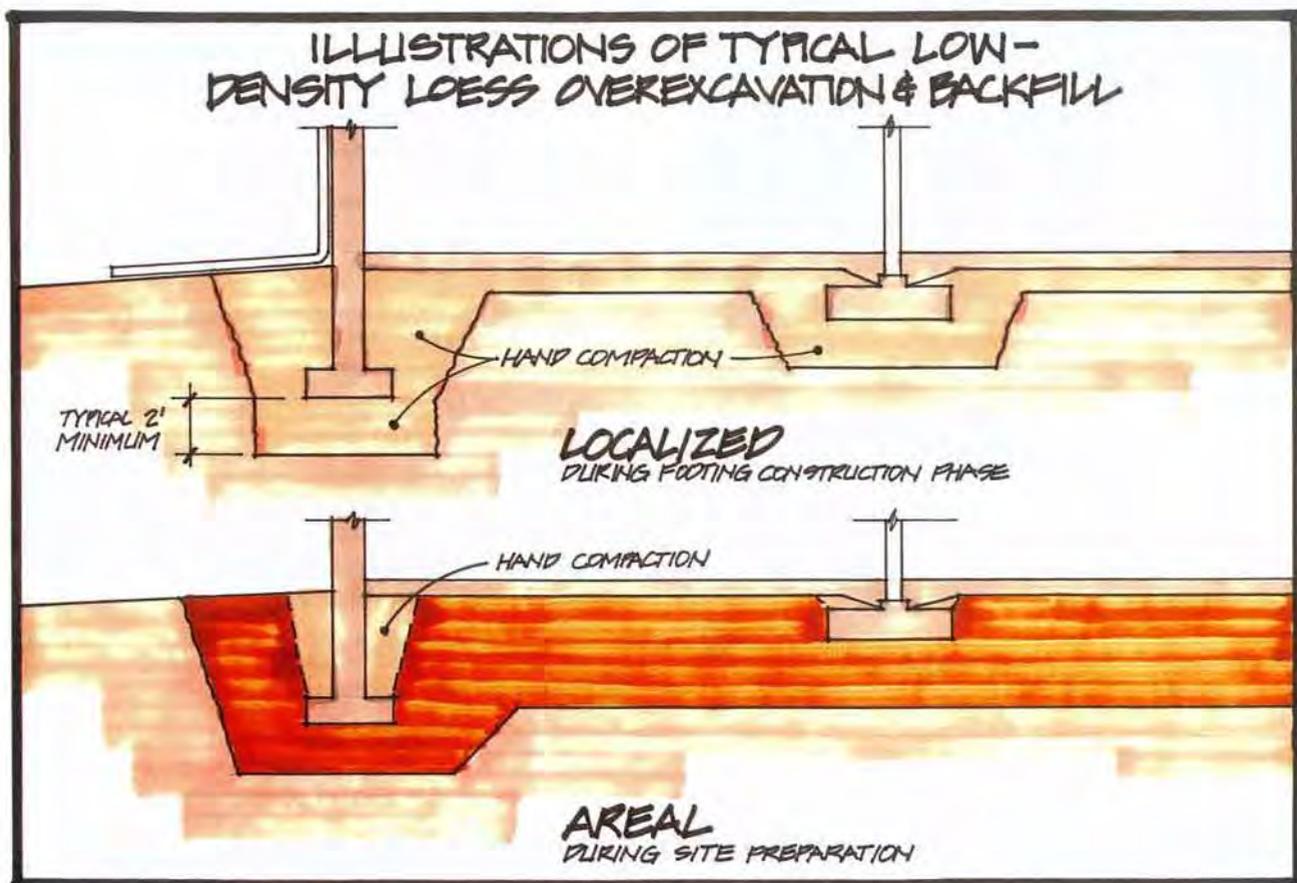
Figure 6. Cross-sections illustrating the partial excavation concept.

Partial excavation generally provides an acceptable level of risk reduction and cost effectiveness, especially for light-to-moderately loaded structures. Common practice is the removal of the loess soils to a depth of at least 2-3 ft below the foundations and floor slabs of the proposed structure.

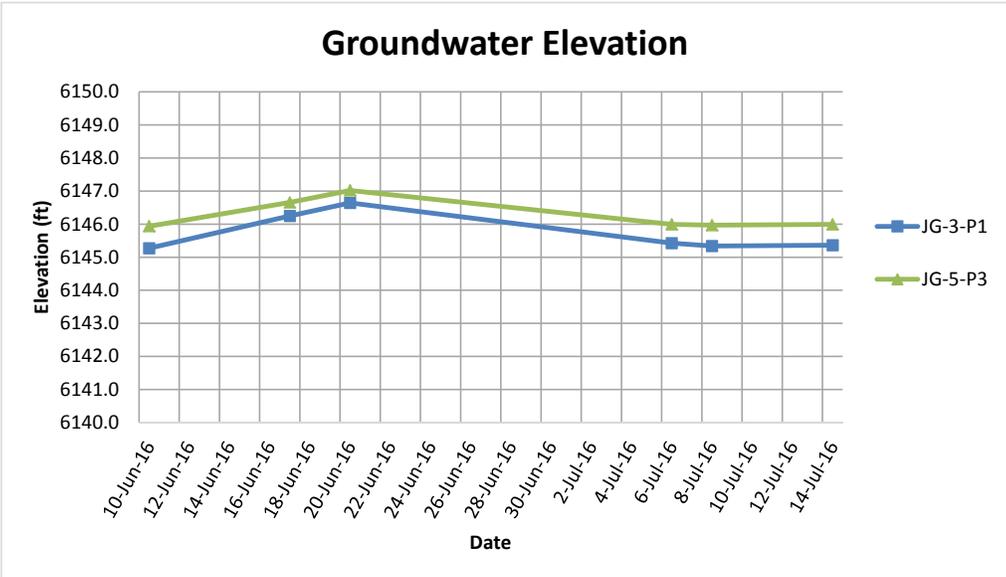
**APPENDIX E**  
**Groundwater Data and Plot**

Piezometer	Borehole Elevation (ft)	Piezometer Depth, bgs (ft)	Piezometer Elevation (ft)	GW Elevation					
				10-Jun-16	17-Jun-16	20-Jun-16	6-Jul-16	8-Jul-16	14-Jul-16
JG-3-P1	6183.8	44	6139.8	6145.3	6146.2	6146.6	6145.4	6145.3	6145.4
JG-5-P2	6220.1	32	6188.1	DRY	DRY	DRY	DRY	DRY	DRY
JG-5-P3	6220.1	69	6151.1	6145.9	6146.7	6147.0	6146.0	6146.0	6146.0

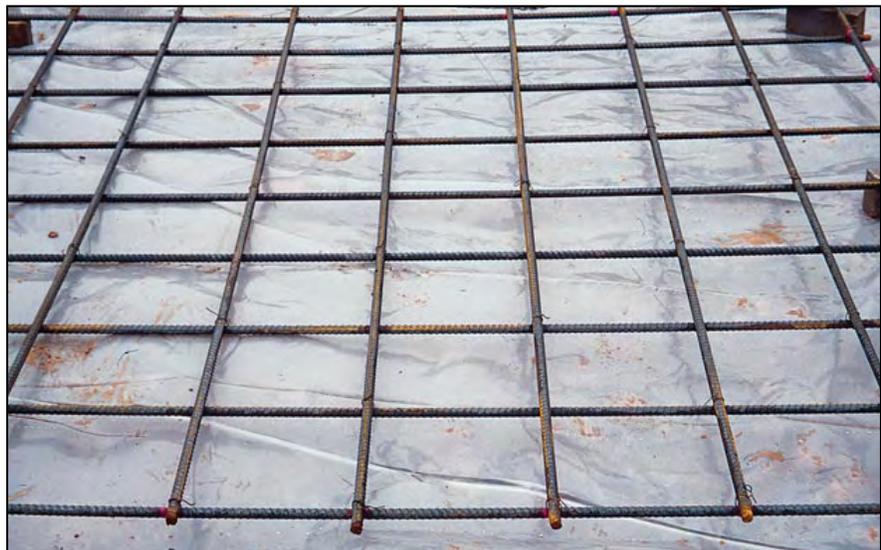
Rebar in concrete slabs placed directly on a vapor retarder help to control slab curling and cracking. Use supported deformed bars no smaller than #4, and space the bars far enough apart so workers can step between them.

control the location of the steel so it doesn't change during floor construction. Because of this, I prefer to use supported deformed bars no smaller than #4 instead of light-gauge mesh. Smaller-diameter bars are too limber, requiring too many bar supports, and light-gauge mesh is difficult to keep in the correct location.

Typically, I specify #4 bars spaced 18 inches on center both ways. This amount of steel holds crack faces together tightly enough for nonrigid floor coverings by maintaining aggregate interlock and significantly reducing slab curling. In some instances, closer spacing or larger-diameter bars may be needed. Constructability becomes an issue when bar spacing is so close that workers

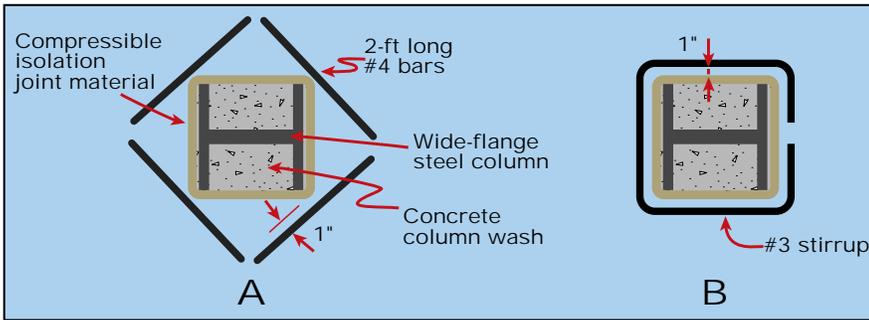
Eliminate the normal isolation-joint box outs at wide-flange steel columns by wrapping the column with compressible material and using 2-foot lengths of #4 bars (A) to control cracking at the reentrant corners. To speed up steel placement at the columns, have the rebar supplier fabricate continuous #3 stirrups that workers can easily bend open to fit around the column (B). In either case, the steel should be positioned with a top-and-side clear cover of 1 inch.

Because the reinforcing steel limits crack width, I prefer to eliminate contraction joints and the traditional diamond-shaped isolation joints at columns when floors will receive a covering. I suggest wrapping wide-flange steel columns for the full floor depth with  $\frac{1}{8}$ - to  $\frac{1}{4}$ -inch-thick compressible isolation-joint material. For floors receiving coverings that won't tolerate wide cracks, such as ceramic tile, I also suggest placing four 2-foot-long #4 bars near the floor surface, with a top-and-side clear cover of 1 inch to control reentrant-corner cracking (Fig. A). As an alternative, the rebar supplier can fabricate #3 bars as a continuous stirrup that can easily be bent open so the ironworker can fit it around the column (Fig. B). This speeds placement of the steel when there are many columns to be treated. The stirrups also should have a 1-inch top-and-side clear cover.

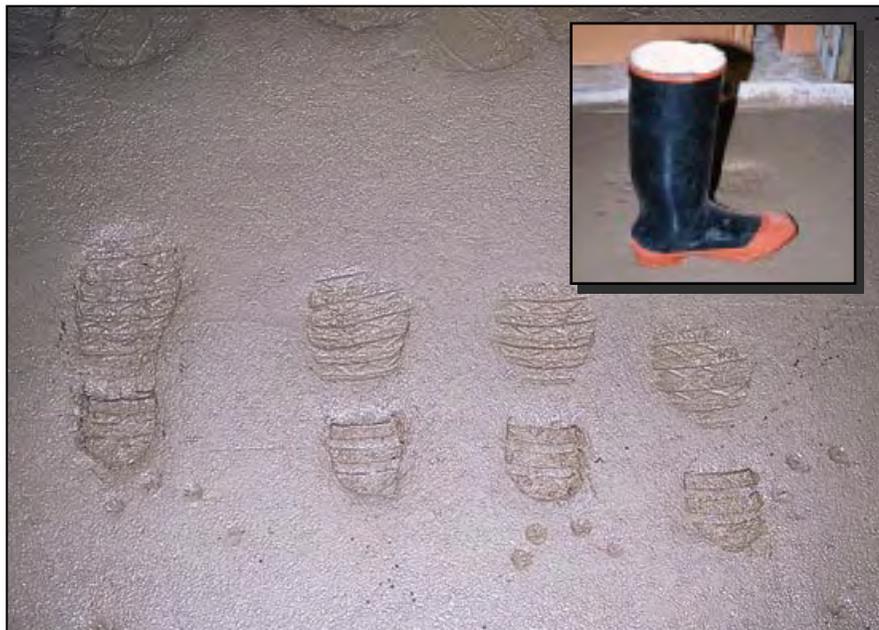
**Figure 1.** Concrete is generally considered to be ready for floating when finishers leave a ¼-inch-deep footprint in the surface. Using a boot filled with steel shot (inset) to produce footprints, we found that 2½-inch-slump concrete placed on a stone base was ready for floating about 45 minutes earlier than the same concrete placed directly on a vapor retarder.

tarder and the other on a crushed-stone base. Technicians periodically set a steel-shot-filled rubber boot weighing 75 pounds on the surface and measured the footprint indentation (Fig. 1). Concrete on the stone base had stiffened enough after 90 minutes to allow a ¼-inch footprint

indentation, an indication that floating could begin. Concrete placed directly on the vapor retarder required 45 more minutes of stiffening time before it was ready for floating.

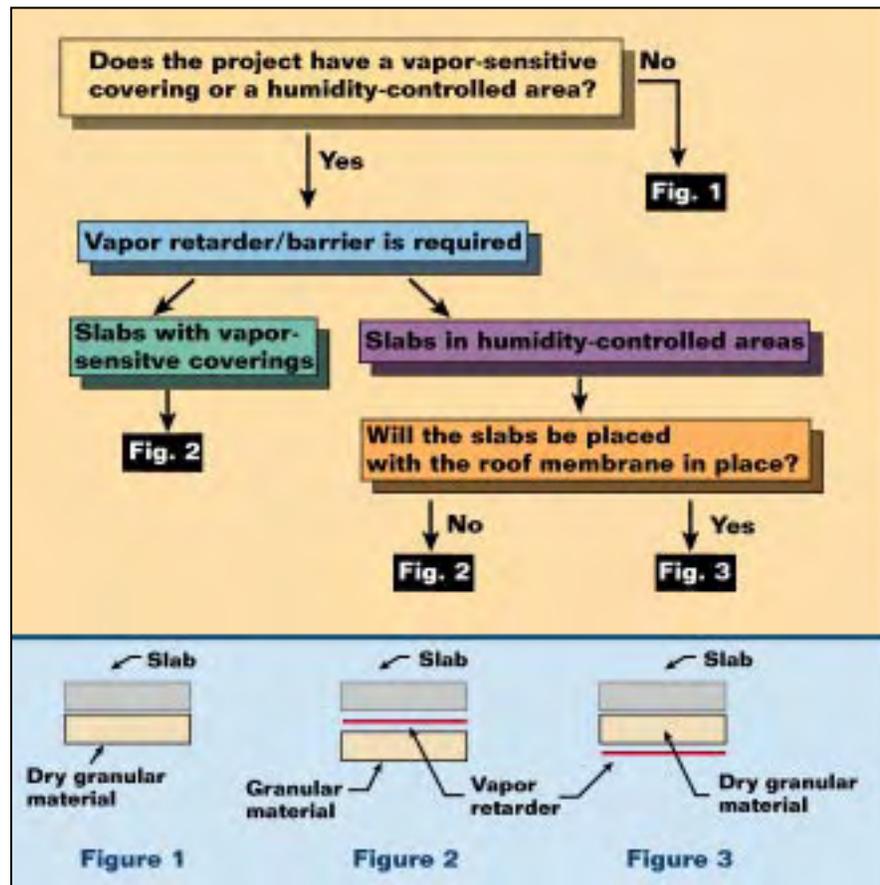
Figure 2. This flow chart helps designers decide if a vapor retarder or barrier is needed and where it should be placed.

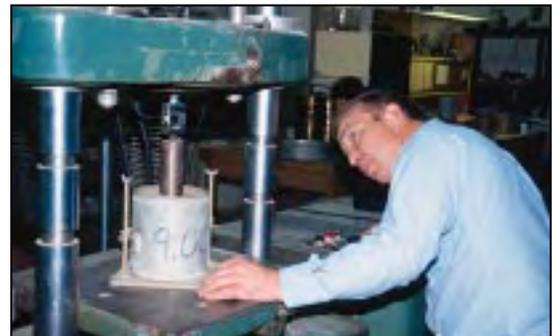
Figure 1. A technician applies load to a compacted soil specimen in a CBR mold. Specimens were loaded with and without sand layers to determine the effect of differing sand-layer thicknesses.

The soil specimen contained in the mold and loaded by the surcharge weights was placed in a testing machine (Fig. 1) that applied load to the piston. A technician measured load and piston penetration distances and used the resulting stress-vs.-penetration curve to compute the CBR values.

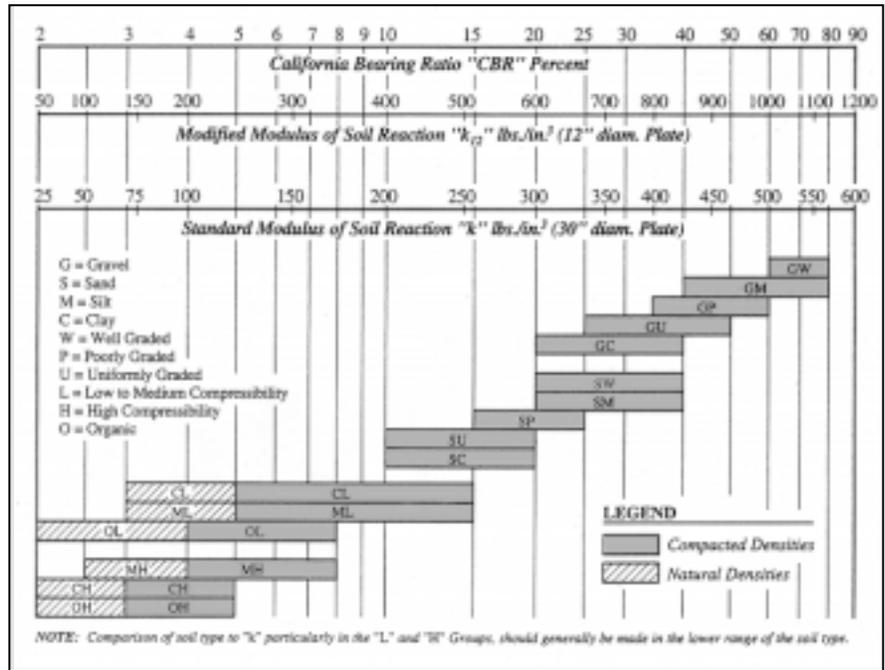
Figure 2. Interrelationships of CBR, k-values and soil classification (from Ref. 2).

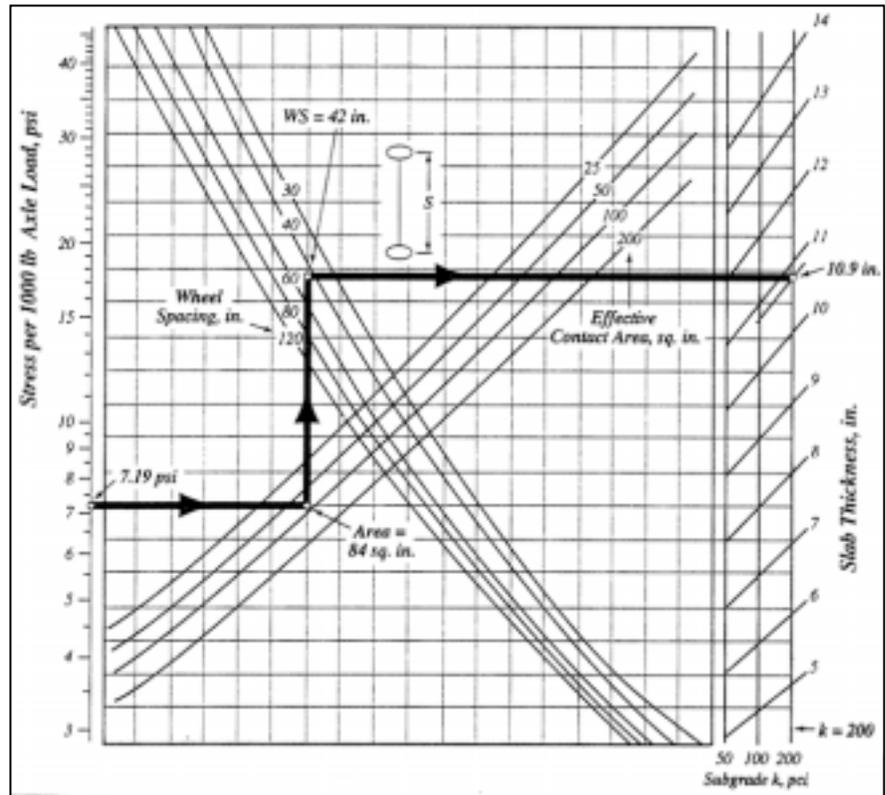
Figure 3. The example in this chart shows that decreasing the k-value from 200 to 50 increases the required slab thickness about an inch. For lighter loadings that yield a thinner slab, the same k-value reduction would still increase thickness about an inch.

What happens if the concrete slab is designed without considering the effect of the sand layer? Based on the design charts and other information (Refs. 2 and 3) for the example shown in Figure 3, the use of a loose sand layer that decreases the k-value from 200 to 50 would result in:

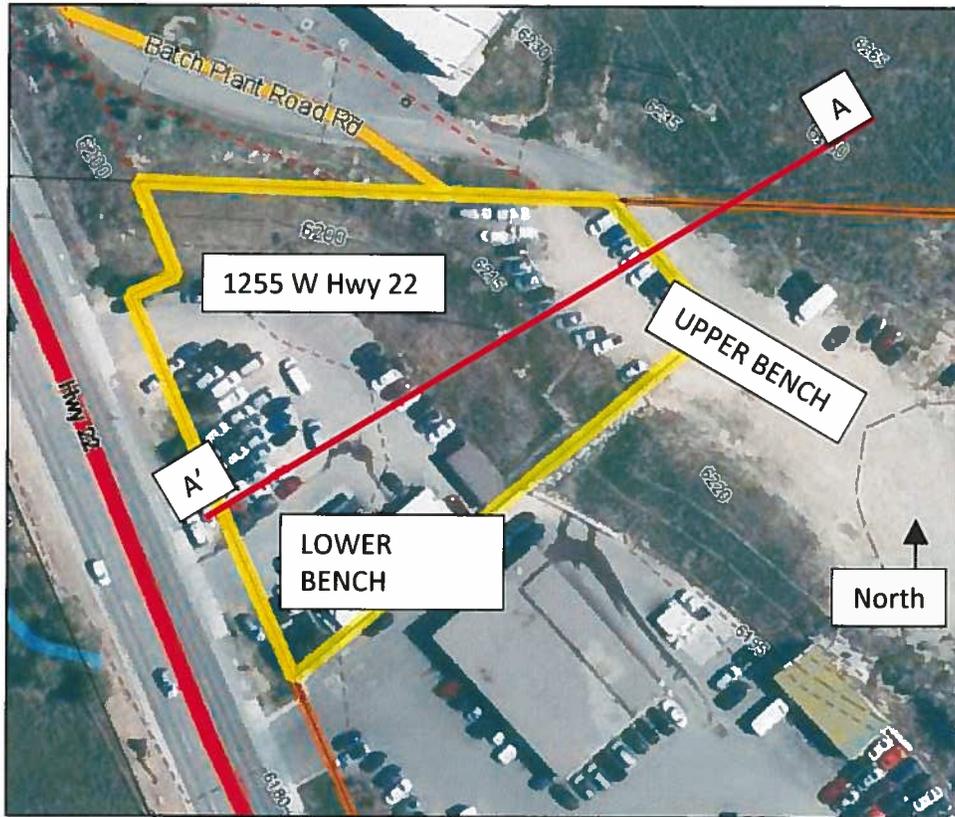
Figure 1: Site Plan and Cross Section Location Map

The project site located in Jackson, Wyoming, along Highway 22 just north of the intersection of Highways 22 and 89, at the southwestern toe of East Gros Ventre Butte. A slope steeper than 30% separates two portions of the lot referred to in this report as the upper and lower benches (Figure 1). Preliminary plans indicate several townhouses are proposed for the lot, including 2 to 3 on the upper bench and 4 to 6 along the toe of the slope on the lower bench.

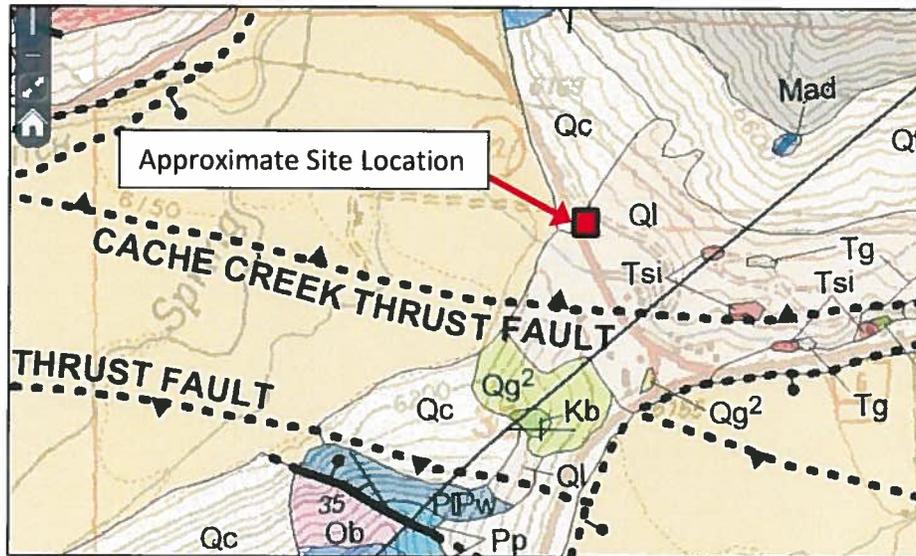
Figure 2: Geologic Map (Love, 2003)

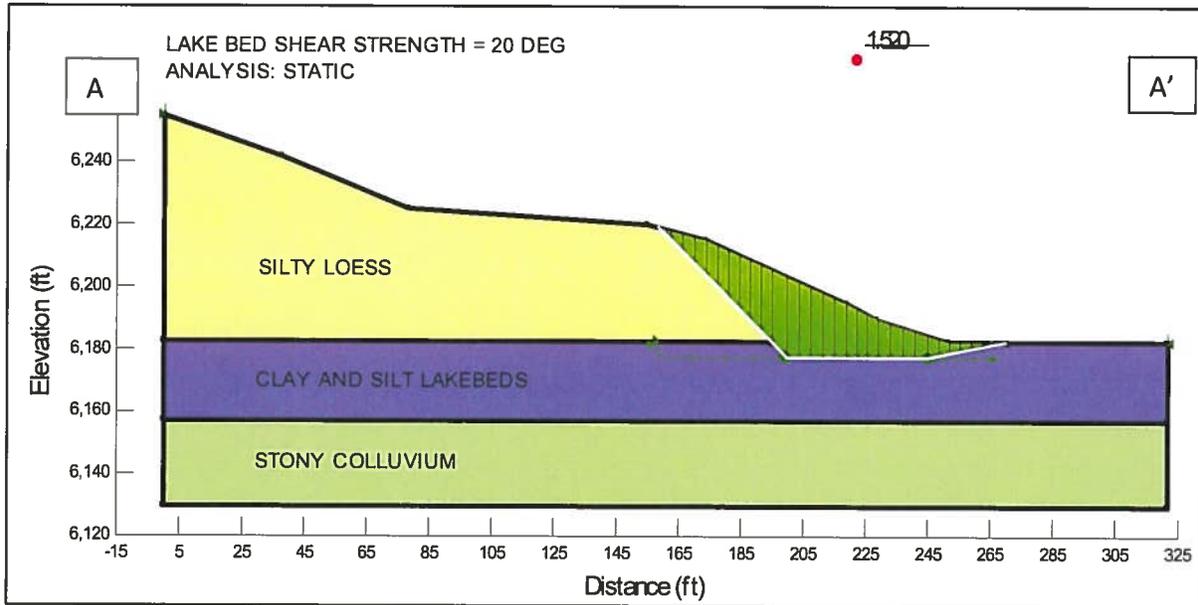
Figure 3: Lower Bound (Residual) Strength of Lakebed Soil - 20°, Static Analysis

7. **Analyses:** The slope stability analyses were performed using the SLOPE/W stability module of GeoStudio 2012 version 8.15.1.11236, produced by GEO-SLOPE International, Ltd. The Morgenstern-Price limit equilibrium method, which takes into moment and force equilibrium, was used to analyze slope stability. Schematic cross-sections are shown on Figures 3, 4, 5, and 6.

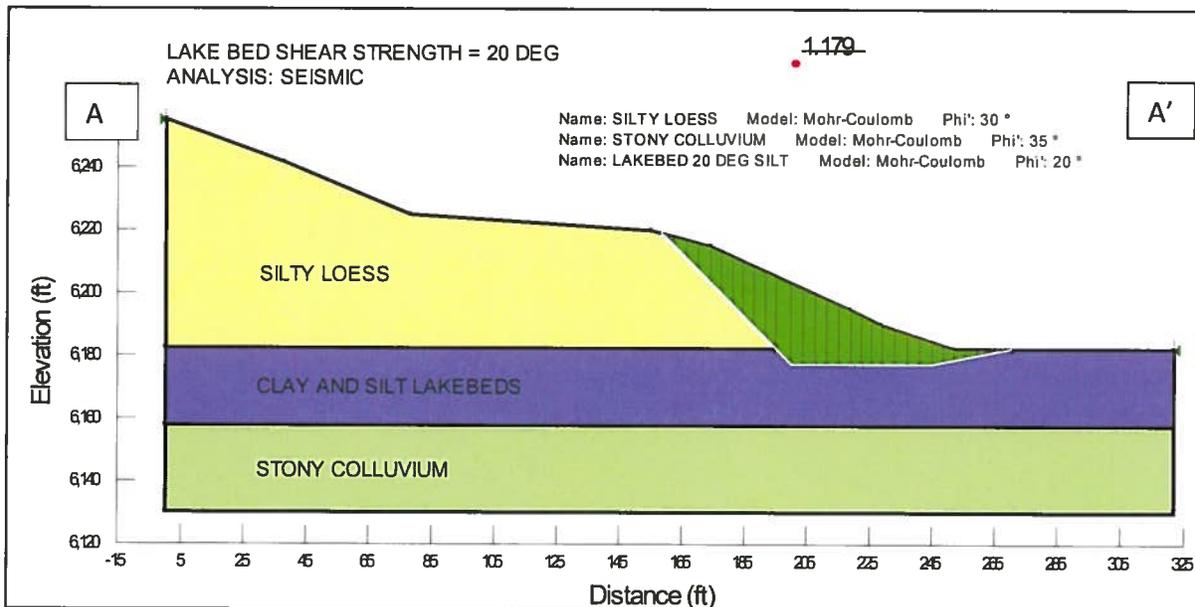
Figure 4: Lower Bound (Residual) Strength of Lakebed Soil - 20°, Seismic Analysis

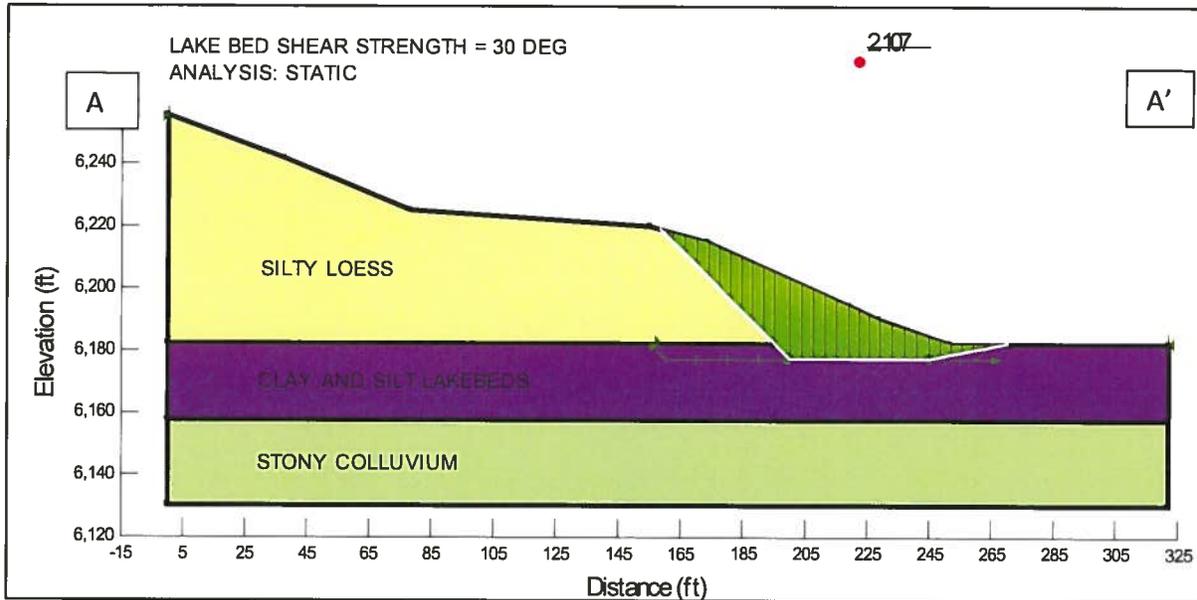
Figure 5: Upper Bound (Peak) Strength of Lakebed Soil - 30°, Static Analysis
