Name/Description: Westview Townhomes

Physical Address: 125 West Highway 22

**-ENVIRONMENTAL ANALYSIS-  
WESTVIEW TOWN HOMES PROJECT,  
JACKSON, WYOMING**

**GEOTECHNICAL INVESTIGATION REPORT  
WEST VIEW TOWNHOMES  
1255 W HIGHWAY 22  
JACKSON, WYOMING**

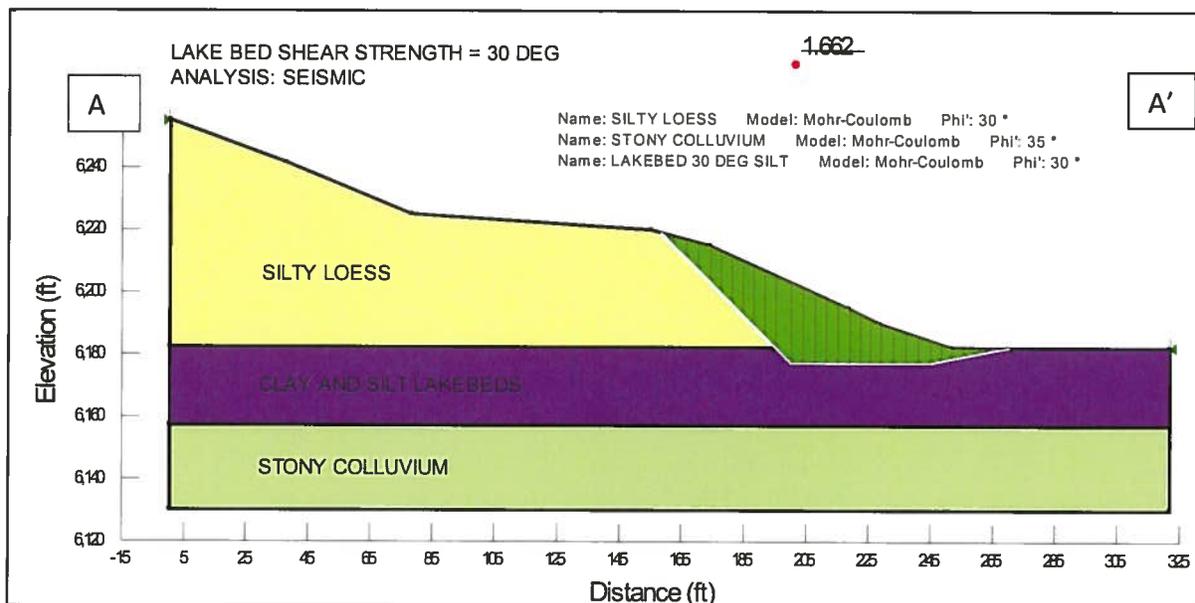
Figure 6: Upper Bound (Peak) Strength of Lakebed Soil - 30°, Seismic Analysis

7. **Analyses:** The slope stability analyses were performed using the SLOPE/W stability module of GeoStudio 2012 version 8.15.1.11236, produced by GEO-SLOPE International, Ltd. The Morgenstern-Price limit equilibrium method, which takes into moment and force equilibrium, was used to analyze slope stability. Schematic cross-sections are shown on Figures 3, 4, 5, and 6.
